READ THIS BEFORE UPDATING SOFTWARE!

When updating software check the OIB sensor and grounds.

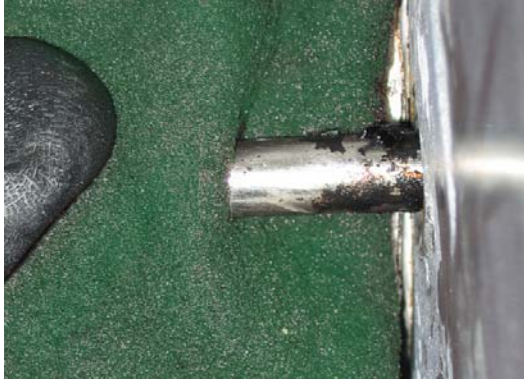
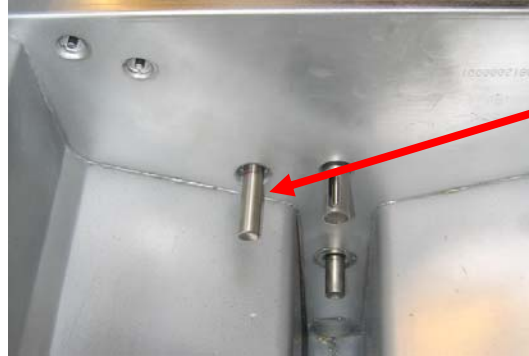
Figure 1

Intermittent IS VAT FULL? displays that occur on LOV and FilterQuick gas fryers is primarily due to dirty OIB sensors or loose grounds. Ensure that the OIB sensors are clean as shown in Figure 1.

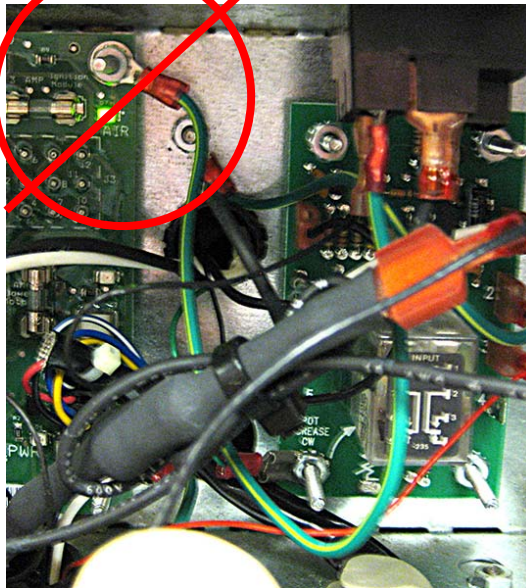
Figure 2

Check the grounds from the OIB relay and 7 second timer board relay. When grounded to the stud on the interface board they have a tendency to loosen. They should **NOT** be grounded to interface board studs as shown in Figure 2. If so they **should be moved and be tightly grounded to stud** in rear of the fryer as shown in Figure 3.
