Instruction Sheet

**Subject: McDonald's UHCTHD
Communication/Configuration Issues**

**Models affected: McDonald's UHCTHD Holding
Cabinets**

12/14/2023

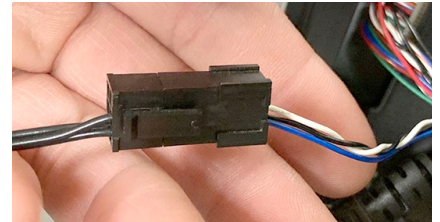
Figure 1

2. If the CAN connections between the rear touch screen and the front touch screen 6-pin blue and white wires (see Figure 1) have been disconnected and reconnected, and no pins on any of the connections have been pushed out of the connections then proceed.
