Instruction Sheet

Subject: Software Update, Sediment Tray Removal, Basket Support Rack Installation and OIB plug Inspection Instructions

Models affected: Taco Bell FilterQuick Touch Gas Fryers (FQG30-T)

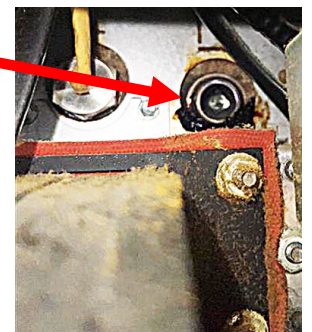
Figure 5

1. Open the doors of the fryer and locate the blower (see Figure 4).
2. Locate the OIB plug directly above and to the right of the blower (see Figure 5). The OIB plug is a 3/8" square socket plug.
3. Take five (5) photos.
 - a. Photo of Sediment Tray removed (see Figure 2).
 - b. Photo of wide shot showing blower and drain area (see Figure 4).

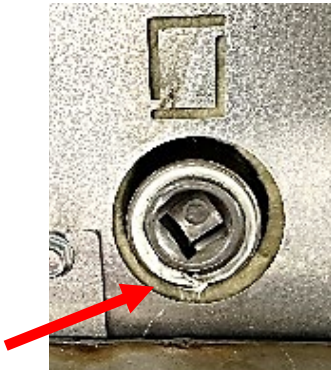
5. Plugs resembling Figure A that appear to have no leakage, should use a ratchet wrench with 15" of extensions, with a 3/8" square tapered wobble head, to rotate the plug clockwise and torque to 54 ft lbs. to ensure they are seated tight in the frypot and not leak (see Figures 8 and 9).

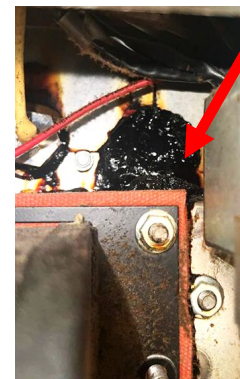
8. Plugs resembling Figure D that have an excess of oil around the OIB plug and in Figure E that shows excessive oil on the ignitors, should knock any oil out of the plug and use a ratchet wrench with 15" of

extensions, with a 3/8" square tapered wobble head, to rotate the plug clockwise and torque to 54 ft lbs. to ensure it is seated tight in the frypot and not leaking (see Figures 8 and 9 above). If it can be determined that oil has entered the insulation, make a note and schedule a second trip to replace the

insulation with kit 8263805. Advise the customer they will be responsible for the cost of repair.
