## Instruction Sheet

**Subject: Software Update, Sediment Tray Removal, Basket Support Rack Installation and OIB plug Inspection Instructions**

**Models affected: Taco Bell FilterQuick Touch Gas Fryers (FQG30-T)**

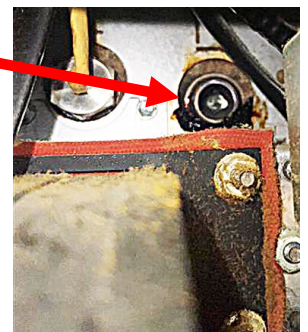
Figure 5

1. Open the doors of the fryer and locate the blower (see Figure 4).
2. Locate the OIB plug directly above and to the right of the blower (see Figure 5). The OIB plug is a 3/8" square socket plug.
3. Take five (5) photos.
  - a. Photo of Sediment Tray removed (see Figure 2).
  - b. Photo of wide shot showing blower and drain area (see Figure 4).

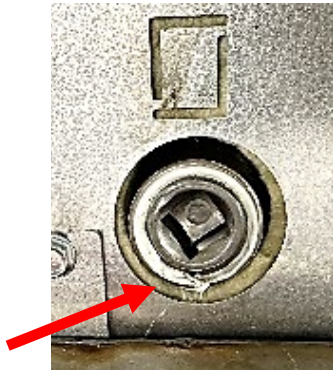
5. Plugs resembling Figure A that appear to have no leakage, should use a ratchet wrench with 15" of extensions, with a 3/8" square tapered wobble head, to rotate the plug clockwise and torque to 54 ft lbs. to ensure they are seated tight in the frypot and not leak (see Figures 8 and 9).

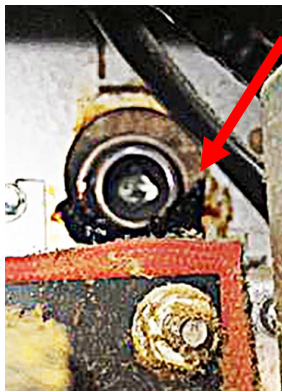
Figure B

6. Plugs resembling Figure B, that appear to have oil around the OIB plug, but **DO NOT** have oil on the ignitor area, should use a ratchet wrench with 15" of extensions, with a 3/8" square tapered wobble head, to rotate the plug clockwise and torque to 54 ft lbs. to ensure it is seated tight in the frypot and not leak (see Figures 8 and 9 above).

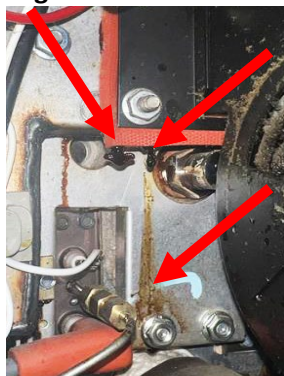
7. Plugs resembling Figure B that have oil around the OIB plug and Figure C with oil around the ignitors should use a ratchet wrench with 15" of extensions, with a 3/8" square tapered wobble head, to rotate the plug clockwise and torque to 54 ft lbs. to ensure it is seated tight in the frypot and not leak (see Figures 8 and 9 above). If it can be determined that oil has entered the insulation, make a note and schedule a second trip to replace the insulation with kit 8263805. Advise the customer they will be responsible for the cost of the repair.

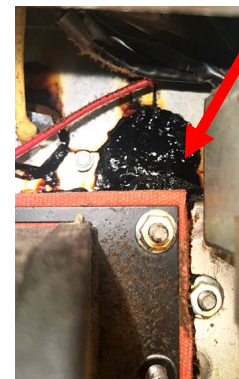
8. Plugs resembling Figure D that have an excess of oil around the OIB plug and in Figure E that shows excessive oil on the ignitors, should knock any oil out of the plug and use a ratchet wrench with 15" of

insulation with kit 8263805. Advise the customer they will be responsible for the cost of repair.
