# Service Bulletin

Bulletin 2003-10-ABDE

Date: 01/16/2003

## SUBJECT: UHC Service Notes

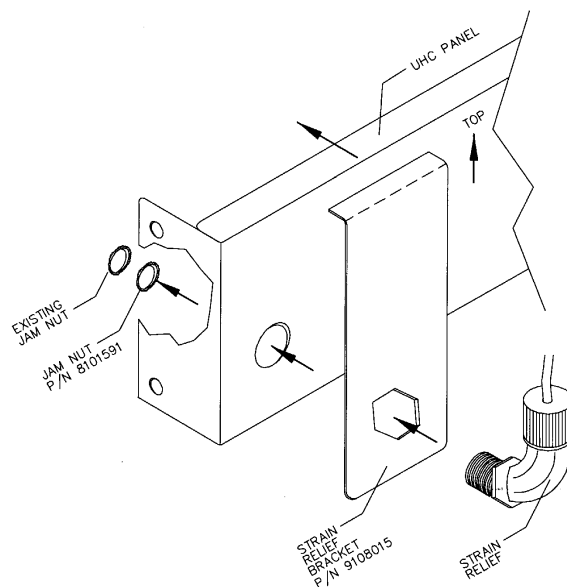
The right angle strain relief on the UHC power cord may loosen. The loosening is usually caused by crewmembers rotating the power cord or strain relief.

It is **important** that the strain relief be secure. When servicing a UHC, check the right angle strain relief. If it is loose, install UHC Strain Relief Kit P/N 826-1495 (illustrated below). Installation of the kit will prevent the strain relief from loosening again. **NOTE:** Inspection of cabinets with a straight strain relief is not necessary.
