Service Bulletin

Bulletin 2003-47-ABDE

SUBJECT: Electrode Positioning in Invensys Pilot Assemblies

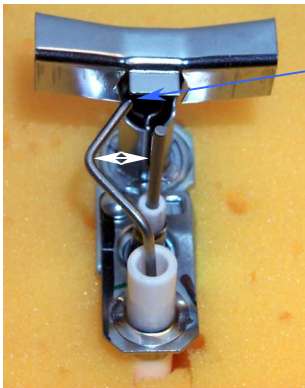
The electrode tip is properly positioned just under the pilot hood deflector corner. (Note orientation of electrode in relation to deflector corner.)

Maintain maximum obtainable distance (white arrows) between electrode and flame sensor when positioning electrode tip with pilot hood.

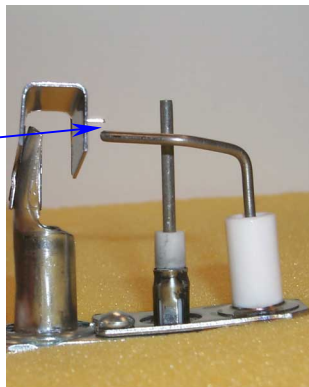
The electrode position in relation to the pilot hood deflector is crucial to accurate ignition. If the electrode is out of adjustment, the spark current will seek an alternate path to the flame-sense rod, causing ignition circuit failure.

After the electrode is positioned and properly adjusted, ensure the flame completely engulfs the flame sensor at all times during operation. Check the pilot flame with all frypots heating to ensure there is no loss of pilot flame.
