Service Bulletin

Bulletin 2004-22-ABDE

SUBJECT: Flexlines on Footprint Pro Electric Fryers

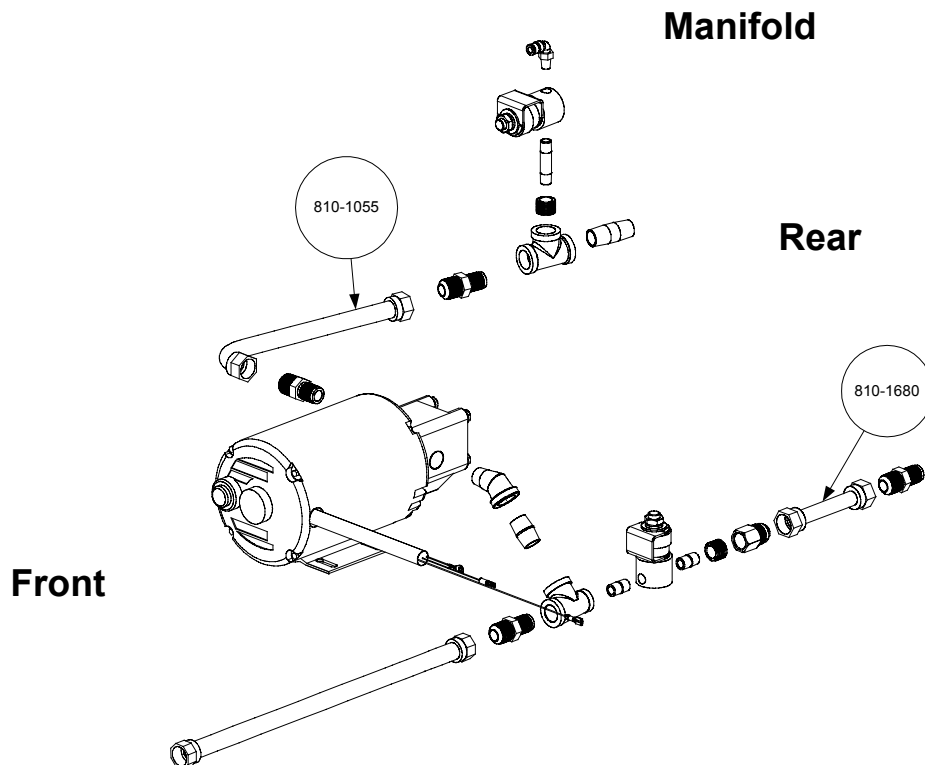
Some Footprint Pro electric fryers have had flexlines fail upon startup. This failure is associated with stresses introduced during shipment. This condition has been corrected on fryers built after 06/11/04.

Check the flexlines, (see illustration below) which connect the filter pump to the oil return plumbing, for signs of stress or cracking. Replace if necessary.

When performing a startup on a Footprint Pro fryer, please carry replacement flexlines: 810-1055, an 11.5-inch line, and 810-1680, a 6.5-inch line; both are 5/8" diameter. Do not operate the filter system without inspecting the flexlines.
