Service Bulletin

Bulletin 2006-18-ABDE**Page 1 of 1****Date: 9/12/2006**

SUBJECT: Frypot Stud Misalignment

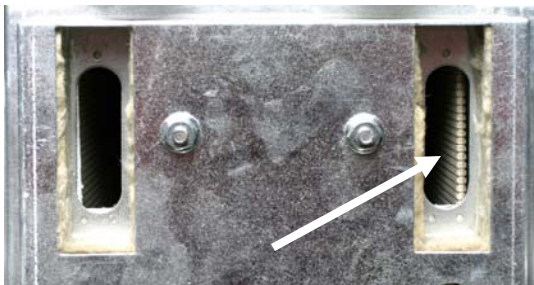
A limited number of service H50/52/55 frypots, splits and fulls, were assembled with misaligned front studs. The result of this misalignment is the igniter can be too close to the burner ceramic, which prevents ignition.

Figure 1: The burner ceramic should not be readily visible when looking straight into the igniter port. The burner in this misaligned frypot (see arrow) extends into the path of the igniter.

Frypots which reveal the misalignment shown in the accompanying photos should not be installed.

If you encounter a frypot exhibiting these defects, contact Frymaster Technical Service, 800-551-8633 or the regional international Frymaster office.

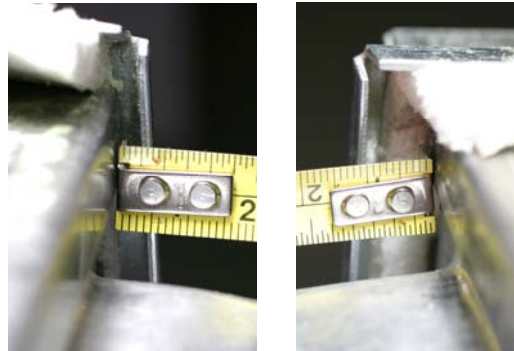
Figure 2: The spacing on the shielding should be within a 1/8" of equal. Frypots that exhibit wide variation from side to side (as shown above) should not be installed.
