Service Bulletin

Bulletin 2007-06-ABDE

SUBJECT: Defective UHC-P Transformer

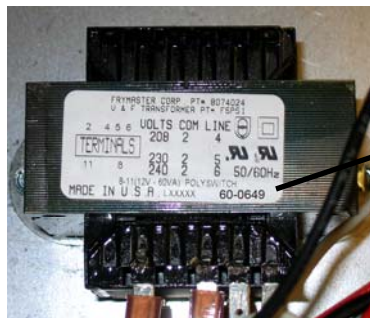
UHC-P cabinets with serial number 0611 or earlier may exhibit dim displays and become unresponsive after 10 minutes of operation. This is attributable to a defective transformer. The troubled transformer, which has a date code of 0649 and below, drops well below 10 volts and remains steady (see Figure 1). The normal output of the transformer is 11 to 13VAC. Symptoms of a defective transformer include dim displays, garbled text and the buttons are not responsive. The low voltage creates a brown-out effect on the electronics, causing the cabinet to become unresponsive. The voltage drop should not be confused with the brief voltage drop to 10 VAC when the unit boots up at initial start up.

Figure 1: Transformer showing date code ending with 0649 and below are to be returned to Frymaster.

This problem affects UHC-P units with a serial number starting with 0611 and below (see Figure 2). Units with a serial number of 0612 and above are not affected. ASA's should check the date codes of service transformers in stock and return any with a date code of 0649 and below to Frymaster.

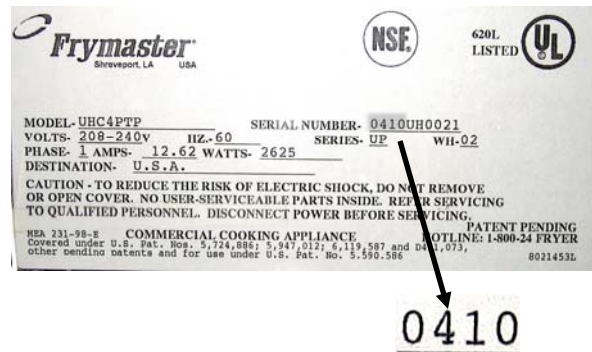
Figure 2: UHC-P Serial plates beginning with numbers 0611 and below are affected.
