Service Bulletin

Bulletin 2007-26-ABDE

SUBJECT: UHC-P Heater Plate Lead Terminals

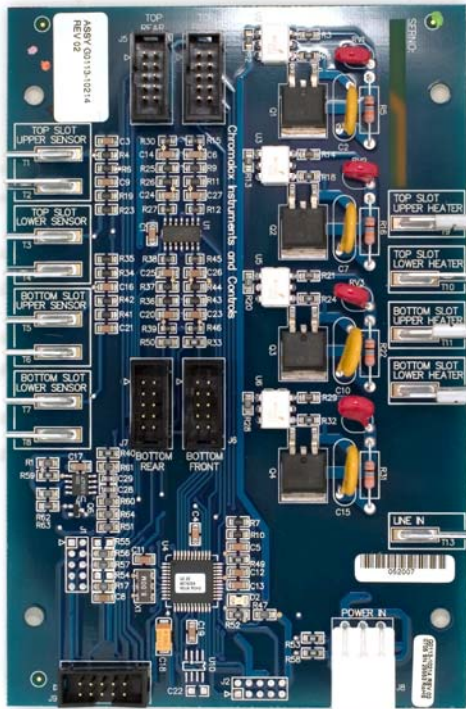
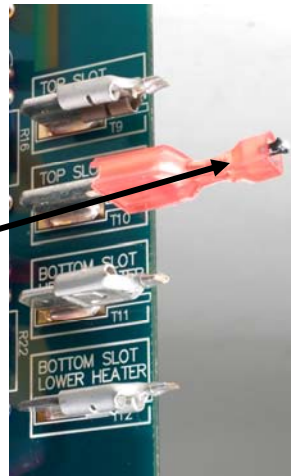
Faulty terminalization on the lead connecting a UHC-P heater plate to the power distribution board can cause heating failure. The date range in which the flaw is possible is limited to cabinets made in mid-August. When responding to an August-built UHC-P with failed or erratic heating, check the terminals of the heater plate leads. On the flawed terminals, it takes very little manipulation to break the wire lead.

Bad crimps on the UHC-P heater plate spade terminals can cause the wire to break or fail to make a good connection, leading to heater failure.

If faulty terminalization is found, cut off the poorly connected spade terminal and crimp on a new terminal.
