Service Bulletin

Bulletin 2007-27-ABDE

SUBJECT: Defective High-limit Thermostat

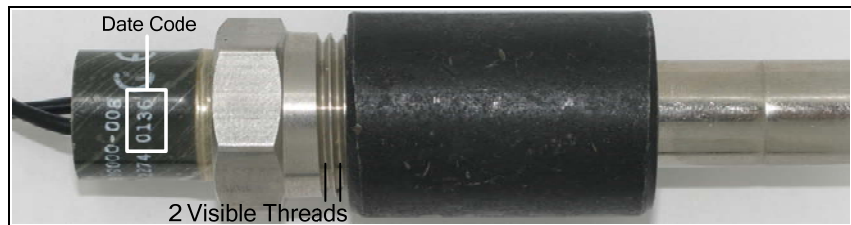
"Good" part.

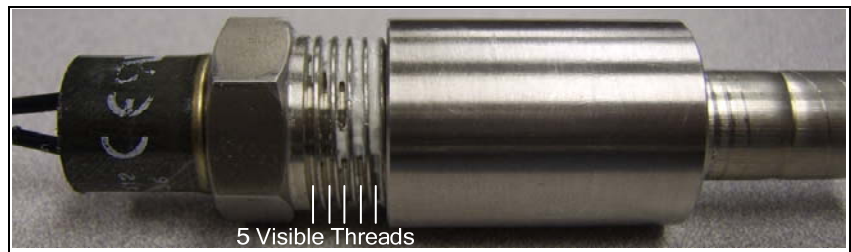
Due to vendor error, a number of high-limit snap disc thermostats have been found to be defective. The ½" NPT male threads are too large and will not properly seal in the ½" NPT couplings. The defective high-limit thermostats will only screw into a ½" NPT coupling approximately ¾ of a turn by hand. A good high-limit will screw into a ½" NPT coupling a minimum of 3 turns by hand.

"Defective" part.

Defective high-limits should be sent back to Frymaster for credit and replacement.
