# Service Bulletin

**Subject: UHC-P Dongle Failure**

**DATE: 9/25/15**

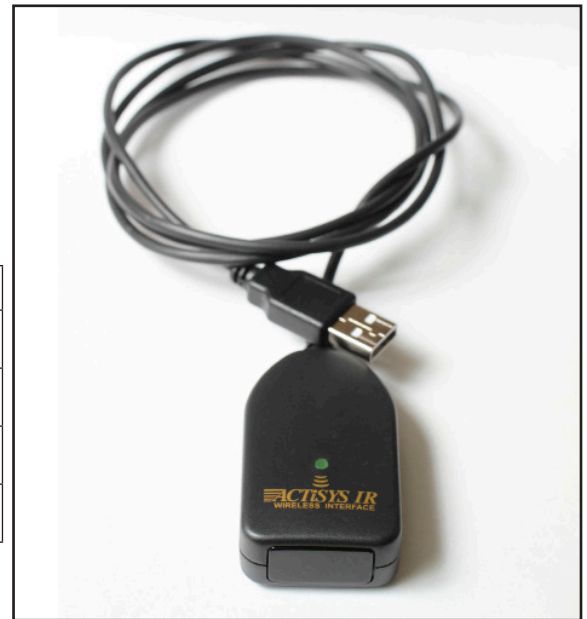
Hardware changes in the infrared device used to program UHC-P's caused the units to fail to communicate with the cabinet. A failure dialog box appears on the associated minicomputer while attempting to communicate with the cabinet. The issue is not with the minicomputer or related components.

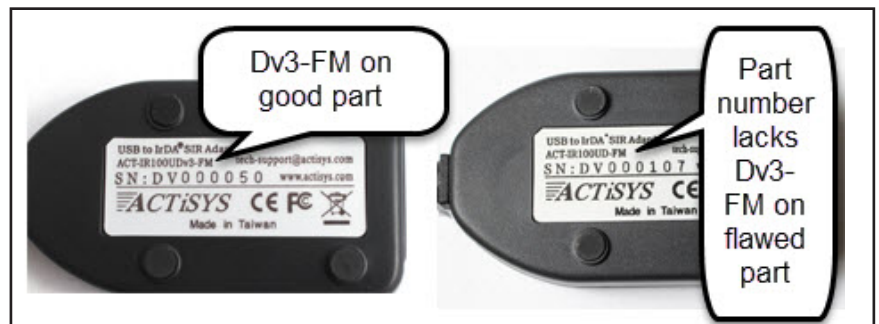
The recently shipped flawed infrared communication devices, called dongles, have a serial number between DV000001 and DV000272 and no number before the

-FM in the Actisys part number. See examples below.

The revised dongles have a 3-FM in the Actisys part number.

The flawed dongle is shown above (right). It is identifiable by the serial number range and the absence of a -3 in the part number. The good part, with the -3 in the part number is shown on the left.

The dongles are provided in four kits (matrix above), which include related communication components. In all cases, dongles in the serial number range without the -3 in the Actisys part number should be returned to Frymaster. In cases where the dongle shipped with a minicomputer, only the flawed dongle needs to be returned.
