## Service Bulletin

### Subject: Revised Work on Electric Fryers with Enhancement Kit Installed

**NOVEMBER 9, 2015**

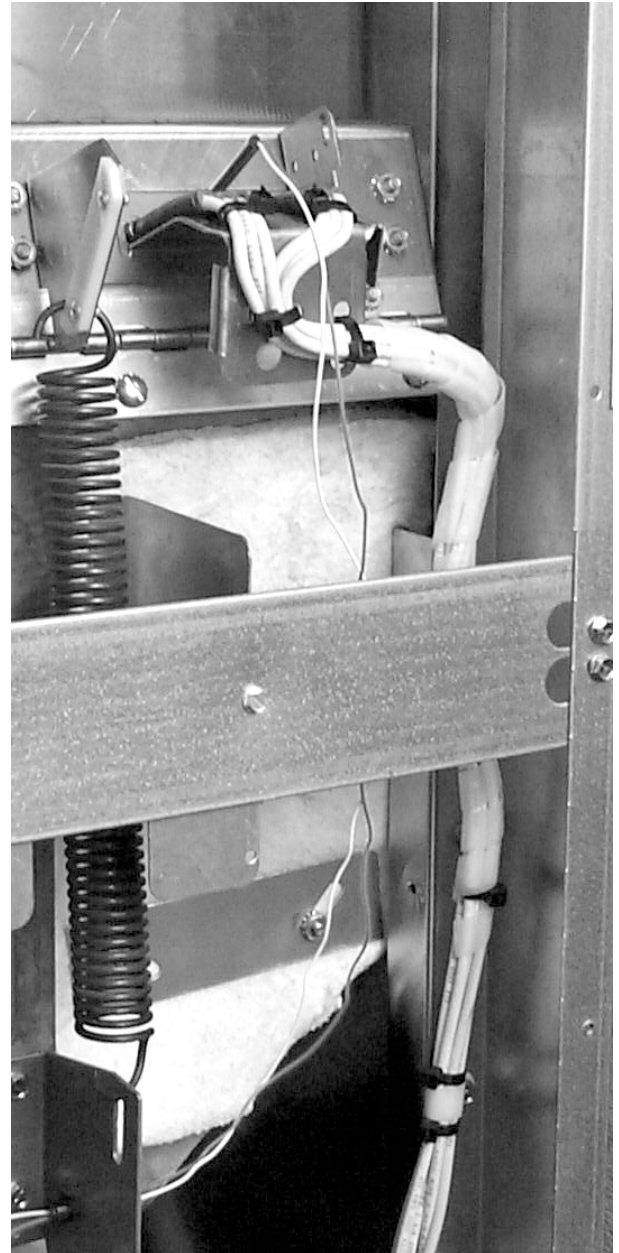
The effectiveness of the enhancements, however, can be compromised by inaccurate work done on the fryer after the retrofit items are installed.

When working on McDonald's electric fryers which have been retrofitted with the enhancement kit, it is essential that the wire routing and wire tie placement conform to the retrofit instructions. Also, wire ties used to secure the element wiring to the bracket must be of sufficient quality to withstand high temperature.

**The placement of wire ties and the routing of element wires must conform to the enhancement kit instructions.**

- Correct routing of cables through the support bracket and the use of high temp resistant blue cable ties,
- The use of sleeves on wiring,
- Wires and connections are checked for tightness and fatigue,
- The back of the fryer is cleaned of excess grease/oil and the cause of build up is assessed,
- Tilt switches are working on elements.
