Service Bulletin

Subject: Electric Contactor Box Transient Voltage Suppression Harness

Models: All Electric Touch Screen Fryers

10/05/2022

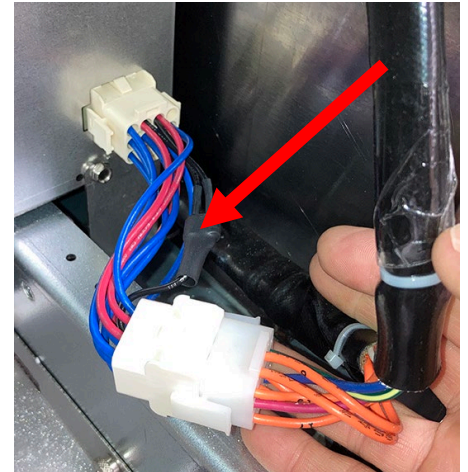
Frymaster **ELECTRIC** Touch Screen Fryers with serial numbers **prior to 2206**, may experience issues with the touch screen controller randomly rebooting and/or SIB (Smart Interface Board) errors, due to electromagnetic interference.

Figure 1 Box prior to 2206 with harness added.

If a fryer is exhibiting these symptoms, attaching an intermediate transient voltage suppression harness (see Figure 1), between the contactor box and contactor box harness will address these issues. Units built 2206 and after have the upgrade integrated into the contactor box assembly (noted by the sticker on the box).

If a fryer has these issues, order enough 8263720 kits for each contactor box in the affected fryer. If more than one fryer is in a store, order enough kits to address both fryers in the store.

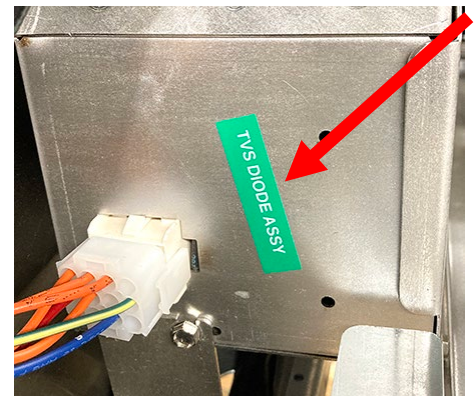
Figure 2 Box 2206 and after with upgrade integrated into the contactor box assembly.
