Service Bulletin

Subject: Pilot Spark Gap

Models: Tube Fryers with Electronic Ignition

03/31/2023

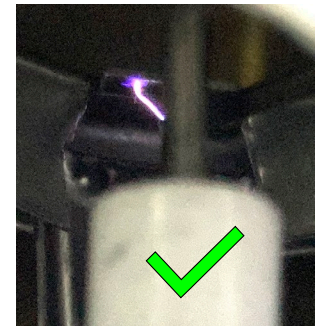
Figure 3

Turn the gas valve to the off position (see Figure 1). Turn on the controller and look through the view port to see the spark (see Figure 2). The spark should be a vertical (see Figure 3) or slightly angled up spark (see Figure 4). Turn the gas valve on and view the spark. There should **NOT** be a horizontal spark (see Figure 5). If so, the pilot needs adjustment.

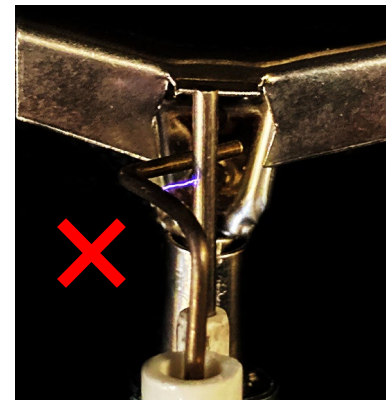
Figure 5

The pilot spark gap on tube fryers with electronic ignition may be incorrect and not ignite properly. The ignitor may be sparking off the flame sensor instead of the pilot hood.

If the any of the gaps are incorrect, adjust the ignitor so that the spark is located at the green lightning bolt (pilot hood) and **NOT** the red lightning bolt (flame sensor) (see Figure 8 on the next page).

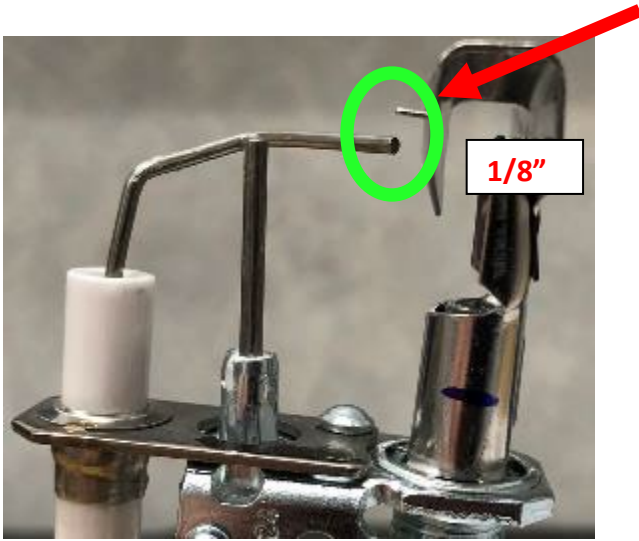
Check the pilot spark gap and ensure the gap is approximately **1/8" inch** from the ignitor to the **left corner to center of the pilot hood** (see Figure 6) and that the gap is **greater than .2"** from the flame sensor to the ignitor (see Figure 7 on the next page).
