Service Bulletin

Subject: UHCTHD Communication/Configuration Errors

Models: McDonald's UHCTHD Touch Screen Holding Cabinets

12/14/2023

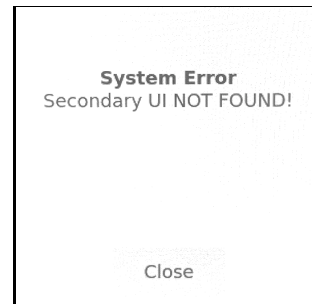
Figure 3

If a UHCTHD Touch cabinet displays "Waiting for Primary UI" (see Figure 1) or "System Error Primary UI communication loss." (see Figure 2) on the **REAR** controller and "System Error Secondary UI NOT FOUND!" (see Figure 3) or "System Error Secondary UI communication loss" (see Figure 4) on the **FRONT** controller, a communication issue has occurred.

Errors shown in Figures 1 and 3 occur when **NO** communication occurs between the front and rear controllers during power up. Errors shown in Figures 2 and 4 occur when communication occurred at power up, but then **was later lost** between the controllers. Pressing the Close button on the front controller, allows it to function normally. The rear controller does not allow the display to clear until the issue is addressed.

If a loss of communication has occurred between the front and rear controllers. See **RESOLUTION A** on the following page to address the issue.

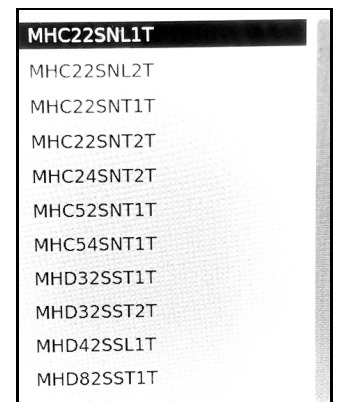
Figure 5

If the rear touch screen displays a Configuration display on the **REAR** touch screen (see Figure 5) and "System Error secondary UI NOT FOUND!" (see Figure 3), or "System Error Secondary UI communication loss" (see Figure 4) on the **FRONT** controller, the rear controller is missing its configuration. **FIRST**, check steps 1-4 on **RESOLUTION A** on the following page to see if this corrects issue. If not, see **RESOLUTION B** on the page 3 to address the missing configuration issue.

1. Follow the 8198006 instructions attached to the rear of this bulletin, to address the missing configuration.

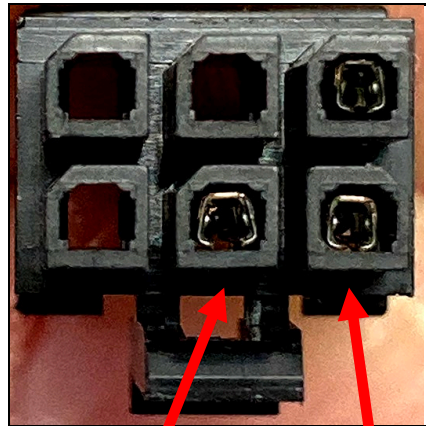
Figure 11

7. Using electrical contact cleaner, clean **BOTH** CAN connectors on the rear of the controllers, with the male pins (see Figure 10).
8. Disconnect and reconnect the CAN cable to both controllers six (6) times.
9. Inspect the CAN cable connectors to ensure **ALL** pins are fully seated into the connectors. Inspect the CAN cable connectors for spread pins (see Figure 11). **NOTE:** The middle pin is spread open compared to the other pins. This may cause intermittent or constant communication issues.

10. If any pins are spread as shown in Figure 11, take a small screwdriver or sharp object that will slide down between the notched side of the connector and the side of the pin. Gently push the sides of the pin back together so the pins make a positive contact (see Figure 12).
