Service Bulletin

Subject: UHCTHD Communication/Configuration Errors

Models: McDonald's UHCTHD Touch Screen Holding Cabinets

9.23.24

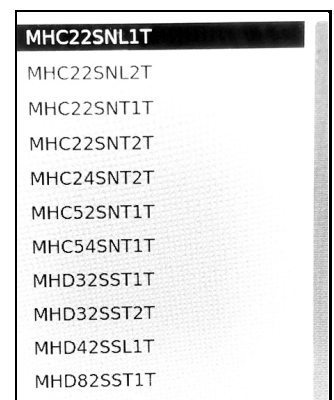
Figure 3

If a loss of communication has occurred between the front and rear controllers (see Figures 1-4). See **RESOLUTION A** on page 2 and UHCTHD CAN and IO Communication Troubleshooting beginning on page 4 of this bulletin to address the issue.

RESOLUTION A (Loss of Communication)

1. Remove the four (4) Phillips screws on the top of the cabinet and remove the cabinet top.

3. Using the kit 8263835, Replace the three wire CAN connection cable between both UI's and replace the IO cables between both UI's and the IO boards.

4. Reconnect the connectors and **POWER CYCLE** the cabinet to check for proper communication.

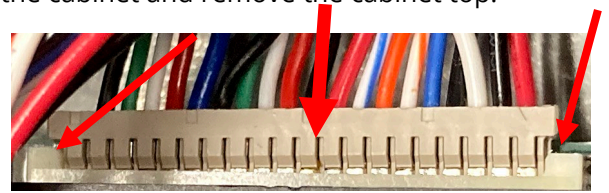
Figure 6

2. **Ensure the connector, that attaches directly to the rear of the touch screen, is fully inserted into the connector by pressing in on both sides of the connector (see Figure 6). The photo shown shows the right side slightly out of the connector. It may require disconnecting and reconnecting the connector. Both sides of the connector should be flush against the connector on the board.**

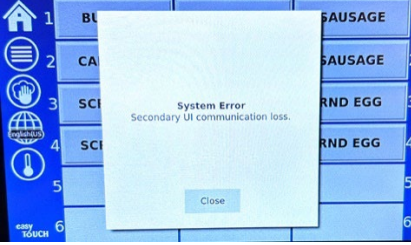
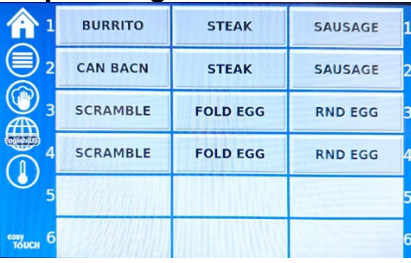
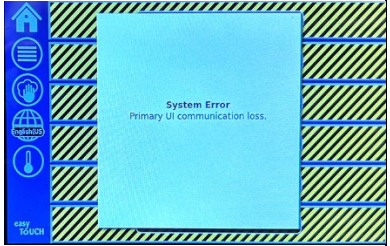
| Front UI | Rear UI | IO COM LED | Possible Cause | Corrective Action(s) | Functions Affected |
|---|--|---|---|---|---|
| <p>System Error Secondary UI communication loss.</p> <p>Close with the Menu in the background</p> <p>Operating Normally after pressing Close button</p> | <p>System Error Primary UI communication loss</p> <p>Hash marks in background indicate IO communication lost as well.</p> | <p>BLINK Yellow</p> | <p>CAN communication cable disconnected, or communication lost between UI's AFTER powering cabinet up.</p> <p>Intermittent CAN harness pins or cable issue.</p> | <p>Ensure CAN communication cable is connected between FRONT and REAR UI's.</p> <p>Order kit 8263835 that includes 2-8076328 and 1-8076441 cables.</p> <p>Replace the 8076441 CAN cable between both UI's and the 8076328 I/O cable between I/O board and REAR UI and power cycle the cabinet.</p> | <p>Rear UI DOES NOT function.</p> <p>Acknowledging the Close button on FRONT UI allows FRONT UI to operate normally.</p> |

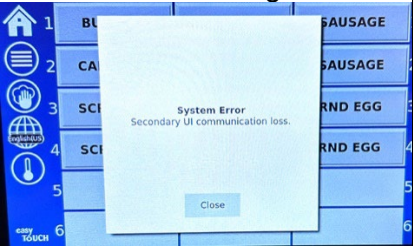
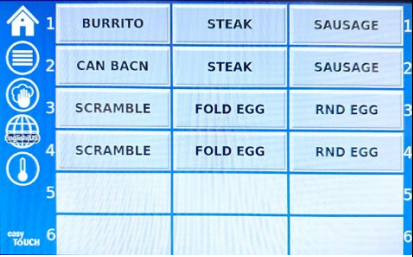
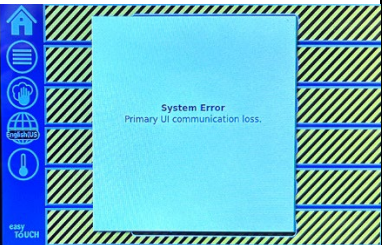
| Front UI | Rear UI | IO COM LED | Possible Cause | Corrective Action(s) | Functions Affected |
|--|--|---|---|--|---|
| <p>System Error Secondary UI communication loss.</p> <p>Close with the Menu in the background</p> <p>Operating Normally after pressing Close button</p> | <p>System Error Primary UI communication loss</p> <p>Hash marks in background indicate IO communication lost as well.</p> | <p>BLINK Yellow</p> | <p>The I/O cable between the REAR UI & I/O board is disconnected at the IO board or UI or intermittent AFTER powering the cabinet up.</p> <p>The 5VDC that operates the CAN bus is lost.</p> <p>CAN bus communication between UI's is lost due to CAN power loss.</p> <p>Disconnected or Bad I/O communication cable between IO board and REAR UI.</p> | <p>Ensure the I/O cable between the REAR UI and I/O board. Ensure the RJ cable connectors are locked into the I/O board connector and the rear connector on the REAR UI.</p> <p>Order kit 8263835 that includes 2-8076328 and 1-8076441 cables.</p> <p>Replace the 8076441 CAN cable between both UI's and the 8076328 I/O cable between I/O board and REAR UI and power cycle the cabinet.</p> | <p>Rear UI DOES NOT function.</p> <p>Acknowledging the Close button on FRONT UI allows FRONT UI to operate normally.</p> |

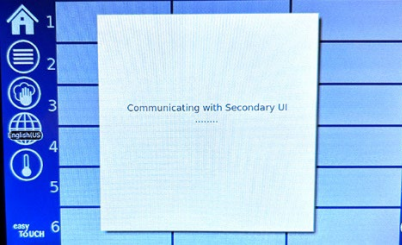
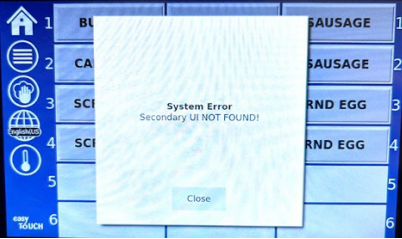
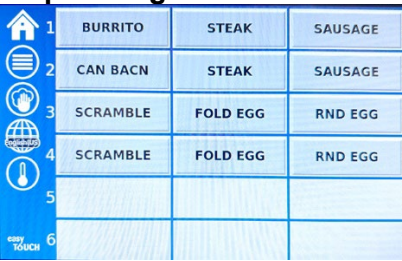
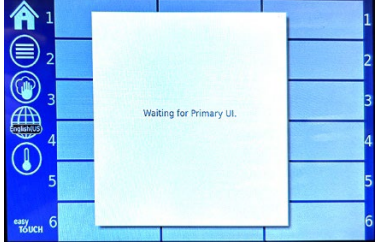
| Front UI | Rear UI | IO COM LED | Possible Cause | Corrective Action(s) | Functions Affected |
|--|--|---|---|---|---|
| <p>Communicating with Secondary UI with incrementing dots.</p> <p>Changing to System Error Secondary UI NOT FOUND! Close with the Menu in the background</p> <p>Operating Normally after pressing Close button</p> | <p>Waiting for Primary UI</p> | <p>BLINK Yellow</p> | <p>CAN communication cable disconnected, or communication lost between UI's BEFORE powering cabinet up.</p> <p>The 5VDC that operates the CAN bus on rear UI is lost.</p> <p>CAN bus communication between UI's is lost due to CAN power loss</p> <p>Intermittent CAN harness pins or cable issue.</p> | <p>Ensure CAN communication cable is connected between FRONT and REAR UI's.</p> <p>Order kit 8263835 that includes 2-8076328 and 1-8076441 cables.</p> <p>Replace the 8076441 CAN cable between both UI's and the 8076328 I/O cable between I/O board and REAR UI and power cycle the cabinet.</p> | <p>Rear UI DOES NOT function.</p> <p>Acknowledging the Close button on FRONT UI allows FRONT UI to operate normally.</p> |

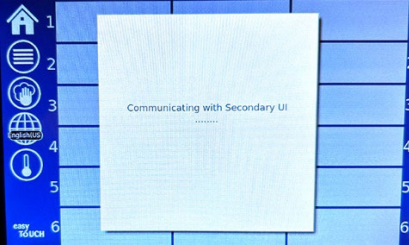
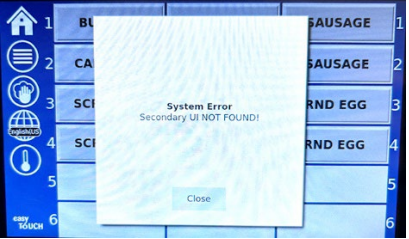
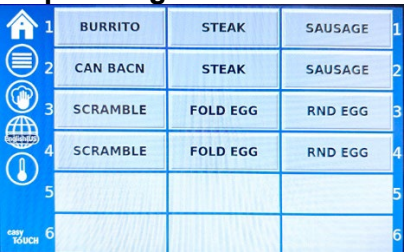
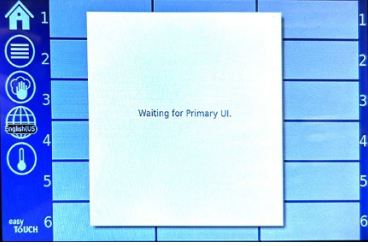
| Front UI | Rear UI | IO COM LED | Possible Cause | Corrective Action(s) | Functions Affected |
|--|--|---|---|--|---|
| <p>Communicating with Secondary UI with incrementing dots.</p> <p>Changing to System Error Secondary UI NOT FOUND! Close with the Menu in the background</p> <p>Operating Normally after pressing Close button</p> | <p>Waiting for Primary UI</p> | <p>BLINK Yellow</p> | <p>The I/O cable between the REAR UI & I/O board is disconnected at the IO board or UI or intermittent BEFORE powering the cabinet up.</p> <p>The 5VDC that operates the CAN bus is lost.</p> <p>CAN bus communication between UI's is lost due to CAN power loss.</p> <p>Disconnected or Bad I/O communication cable between IO board and REAR UI.</p> | <p>Ensure the I/O cable between the REAR UI and I/O board. Ensure the RJ cable connectors are locked into the I/O board connector and the rear connector on the REAR UI.</p> <p>Order kit 8263835 that includes 2-8076328 and 1-8076441 cables.</p> <p>Replace the 8076441 CAN cable between both UI's and the 8076328 I/O cable between I/O board and REAR UI and power cycle the cabinet.</p> | <p>Rear UI DOES NOT function.</p> <p>Acknowledging the Close button on FRONT UI allows FRONT UI to operate normally.</p> |

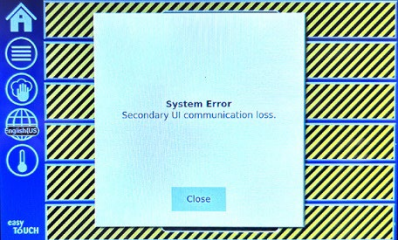
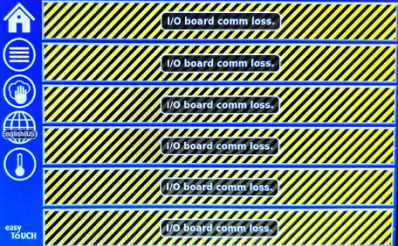
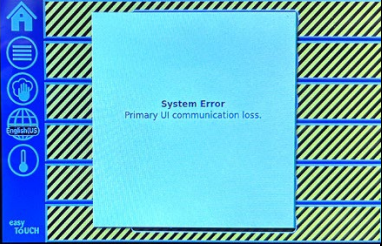
| Front UI | Rear UI | IO COM LED | Possible Cause | Corrective Action(s) | Functions Affected |
|--|---|---|---|---|--|
| <p>System Error Secondary UI communication loss. Close with the Menu in the background</p> <p>Pressing Close changes to I/O board comm loss with Hash Marks in the background</p> | <p>System Error Primary UI communication loss</p> <p>Hash marks in background indicate I/O communication lost as well.</p> | <p>DOES NOT BLINK</p> | <p>The I/O cable between the FRONT UI & I/O board is disconnected at the IO board or UI or intermittent AFTER powering the cabinet up.</p> <p>The 5VDC that operates the CAN bus is lost.</p> <p>CAN bus communication between UI's is lost due to CAN power loss.</p> <p>Disconnected or Bad I/O communication cable between IO board and FRONT UI.</p> | <p>Ensure the I/O cable between the FRONT UI and I/O board. Ensure the RJ cable connectors are locked into the I/O board connector and the rear connector on the FRONT UI.</p> <p>Order kit 8263835 that includes 2-8076328 and 1-8076441 cables.</p> <p>Replace the 8076441 CAN cable between both UI's and the 8076328 I/O cable between I/O board and FRONT UI and power cycle the cabinet.</p> | <p>Acknowledging the Close button on FRONT UI momentary clears message.</p> <p>I/O Board Communication Loss.</p> <p>Neither UI allows any functions.</p> |

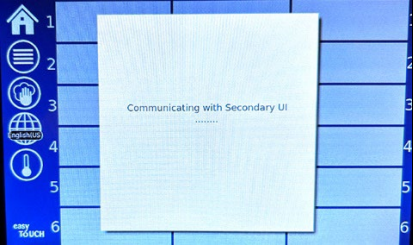
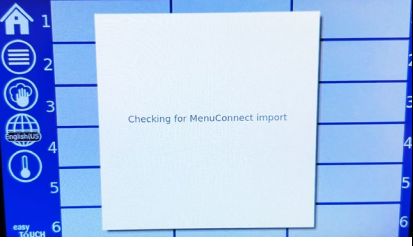
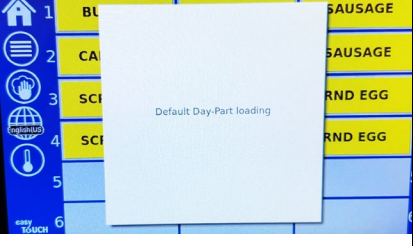
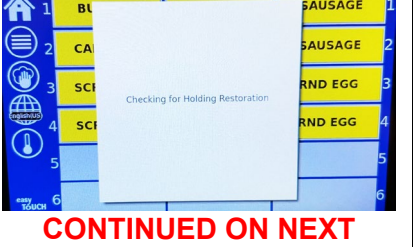
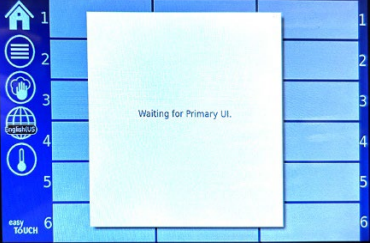
| Front UI | Rear UI | IO COM LED | Possible Cause | Corrective Action(s) | Functions Affected |
|---|---|---|--|---|--|
| <p>Communicating with Secondary UI with incrementing dots.</p> <p>Changing to Checking for MenuConnect import</p> <p>Changing to Default Day-Part loading</p> <p>Changing to Checking for Holding Restoration</p> <p>CONTINUED ON NEXT PAGE</p> | <p>Waiting for Primary UI with NO Hash marks</p> | <p>BLINK Yellow</p> | <p>The I/O cable between the FRONT UI & I/O board is disconnected at the IO board or UI or intermittent BEFORE powering the cabinet up.</p> <p>The 5VDC that operates the CAN bus is lost to the FRONT UI.</p> <p>CAN bus communication between UI's is lost due to CAN power loss.</p> <p>Communication to IO board is lost.</p> <p>Disconnected or Bad I/O communication cable between IO board and FRONT UI.</p> | <p>Ensure the I/O cable between the FRONT UI and I/O board. Ensure the RJ cable connectors are locked into the I/O board connector and the rear connector on the FRONT UI.</p> <p>Order kit 8263835 that includes 2-8076328 and 1-8076441 cables.</p> <p>Replace the 8076328 I/O cable between I/O board and FRONT UI and power cycle the cabinet.</p> | <p>Acknowledging the Close button on FRONT UI momentary clears message.</p> <p>I/O Board Communication Loss.</p> <p>Neither UI allows any functions.</p> |

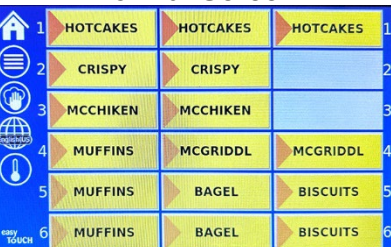
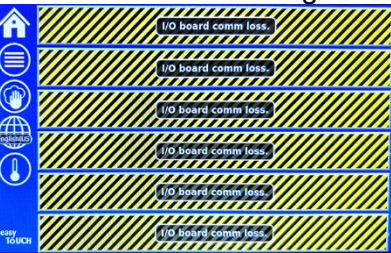
| Front UI | Rear UI | IO COM LED | Possible Cause | Corrective Action(s) | Functions Affected |
|---|---|---|---|---|---|
| <p>Changing to System Error Secondary UI NOT FOUND! Close with NO Hash Marks in the background</p> <p>Pressing Close Momentary changes to Normal Screen</p> <p>Changing to I/O board comm loss with Hash Marks in the background</p> | | | See previous page | See previous page | See previous page |
