Service Bulletin

Subject: Loose Sana Grid Hardware

Models: International XYCFHC118/218/318, XYCFRE118, XYSCHF218/318, XYSCHFRE218/318, YSCFHC218/318, YSCFHC214, 2FQE80, FPRE380/680, XFPRE280/380/480/580

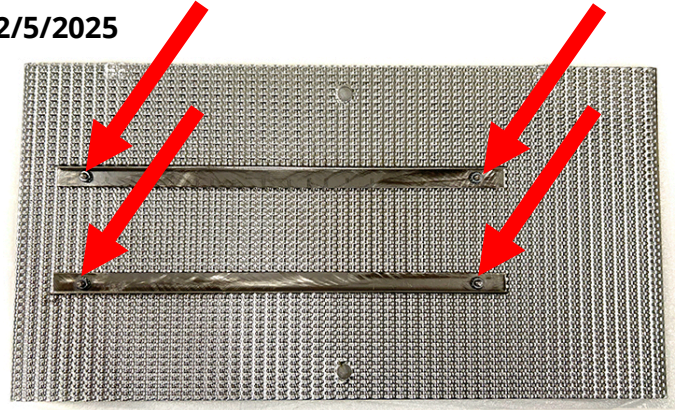
Figure 1

Hardware on some Sana Grid screens with stiffeners, manufactured with serial #'s starting with 2311 through 2501, may have loosened up during shipment and fallen off in the filter pan. If this hardware is pumped into the filter pump, it may damage the pump.
