Service Bulletin

Subject: Float Switch Clip, Float Inspections & Troubleshooting

Models: FQG60T, FQG80T, FQG100T & FQG120T Touch Screen Fryers

7/2/2025

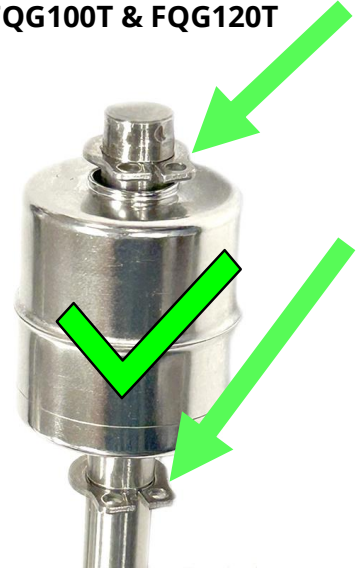
1. If the float switch has a **HEAVY-DUTY GRIP RING** supplied by the manufacturer on **TOP OF THE FLOAT** **AND** a **HEAVY-DUTY GRIP RING BELOW THE FLOAT** (see Figure 1), the float is good stock and **DOES NOT NEED TO BE REPLACED**.
2. If the float switch has an **INDENTED TRIANGLE ON THE TOP OF THE FLOAT** (see Figure 2), it **MUST** have a **GRIP RING ONLY** on the **TOP OF THE FLOAT**. If it has an **E-clip** on **TOP OF THE FLOAT** (see Figure 3), the **E-clip** **MUST BE REPLACED** with a **GRIP RING**.

Figure 1 Heavy Duty Grip Ring on Top & Bottom.

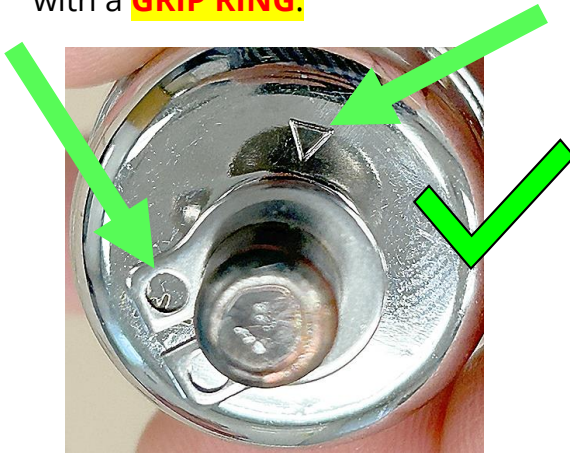
Figure 2 Float switch showing Indented Triangle & Grip Ring on Top.

Float switches **WITH** the **INDENTED TRIANGLE** that need grip rings, should order kit 8263865, which contains 7 (seven) grip rings. **GOOD** external Snap Ring pliers **will be required** to install the grip rings.

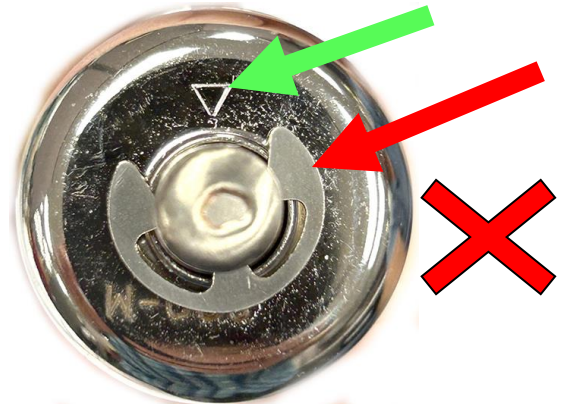
Figure 3 Float switch showing E-clip.

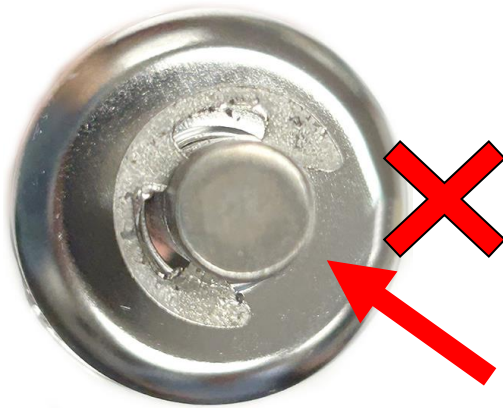
3. If the float **DOES NOT HAVE A TRIANGLE** on the **TOP OF THE FLOAT** (see Figure 4) **AND** it has an **E-clip BENEATH THE FLOAT** (see Figure 5), **IT MUST BE REPLACED** with kit PN 8262541!

Figure 4 Float switch with **NO** triangle on top.

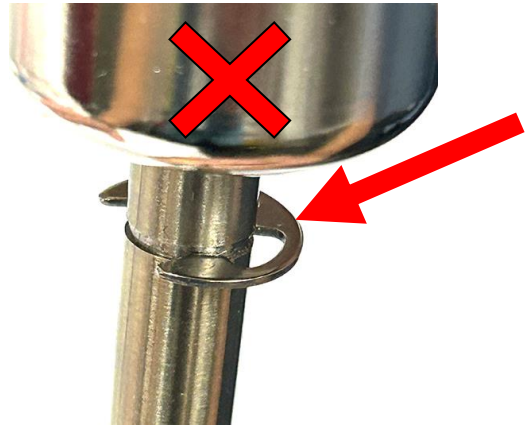
Figure 5 Float switch with E-Clip beneath the float that **DOES NOT** have a triangle on the top.

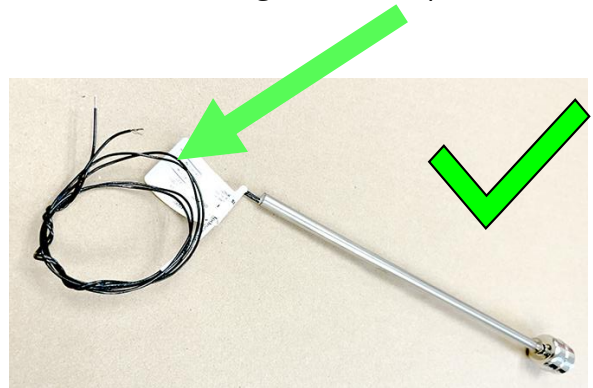
Figure 6

When replacing float switches with kit PN 8262541, ensure that only float switches **WITH BLACK LEADS ONLY** (see Figure 6) are used as replacements.

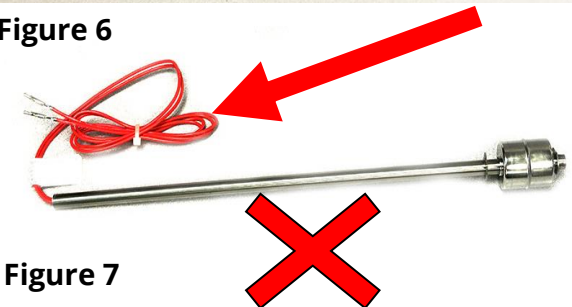
Figure 7

FAS's should order replacement kits first. Once they receive the new kits, they should return any 8262541 kits with **RED** leads (see Figure 7).

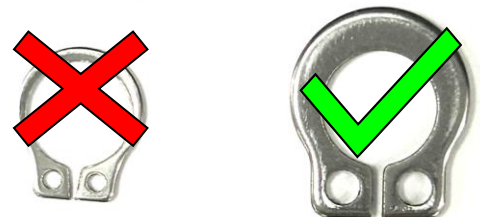
Figure 8

Standard snap rings **SHOULD NOT** be used (see snap ring on the left in Figure 8). They will not hold and will come loose.

ONLY HEAVY-DUTY GRIP RINGS from the manufacturer (see grip-ring on right in Figure 8) should be used.

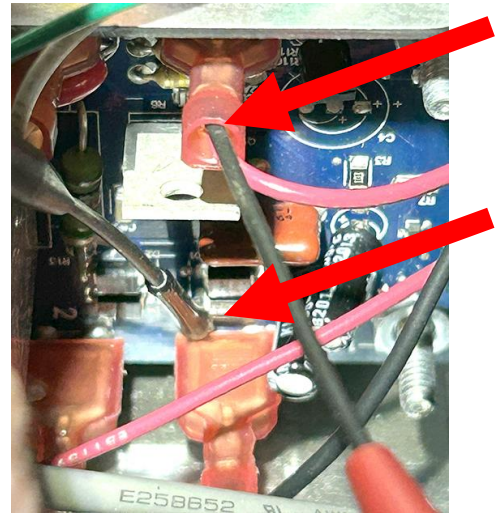
Figure 8

- i. Test across pins 1 (Red) & 8 (Black) (see Figures 8, 10 & 11). 24VDC should be present with the switch activated.
- ii. Test **across pins** 6 (green) & 7 (white) or 2 & 3, depending which pins have green and white attached (see Figures 9, 10 & 11). The voltage should be near 0VDC when activated. If the voltage is above 0.3VDC with power on and contacts closed, the time delay relay must be replaced.
