Service Bulletin

Subject: Float Switch Clip, Float Inspections & Troubleshooting

Models: FQG60T, FQG80T, FQG100T & FQG120T Touch Screen Fryers

7/16/2025

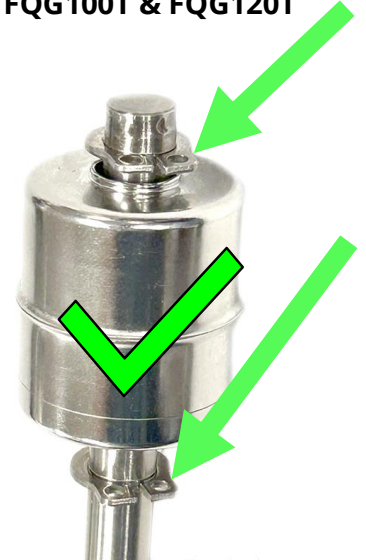
Figure 1 Heavy Duty Grip Ring on Top & Bottom.

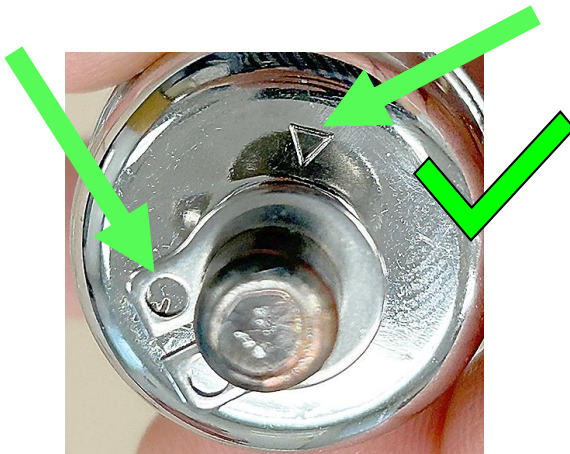
Figure 2 Float switch showing Indented Triangle & Grip Ring.

Float switches **WITH** the **INDENTED TRIANGLE** that need grip rings, should order kit 8263865, which contains 9 (nine) grip rings. **GOOD** external Snap Ring pliers **will be required** to install the grip rings.

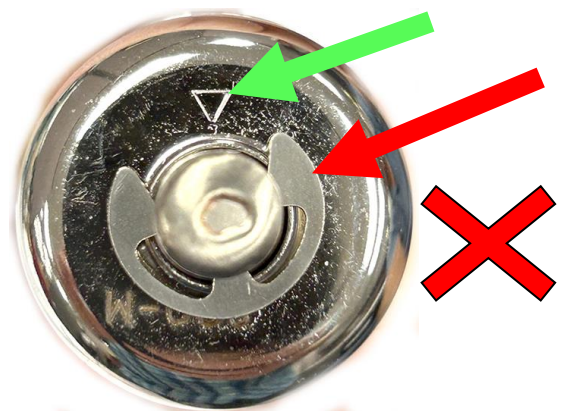
Figure 3 Float switch showing E-clip.

1. If the float switch has a **HEAVY-DUTY GRIP RING** supplied by the manufacturer on **TOP OF THE FLOAT** **AND** a **HEAVY-DUTY GRIP RING BELOW THE FLOAT** (see Figure 1), the float is good stock and **DOES NOT NEED TO BE REPLACED**.
2. If the float switch has an **INDENTED TRIANGLE ON THE TOP OF THE FLOAT** (see Figure 2), it **MUST** have **GRIP RINGS** on the **TOP & BOTTOM OF THE FLOAT** (see Figure 1). If it has **E-clips** on **TOP & BOTTOM OF THE FLOAT** (see Figure 3), the **E-clips** **MUST BE REPLACED** with **GRIP RINGS**!

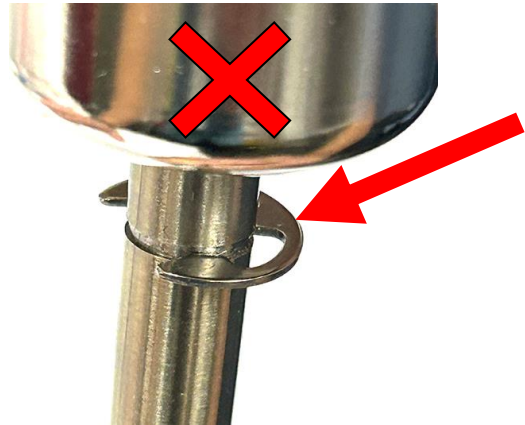
Figure 5 Float switch with E-Clip beneath the float that **DOES NOT** have a triangle on the top.

3. If the float **DOES NOT HAVE A TRIANGLE** on the **TOP OF THE FLOAT** (see Figure 4) **AND** it has an **E-clip BENEATH THE FLOAT** (see Figure 5), **IT MUST BE REPLACED** with kit PN 8262541!

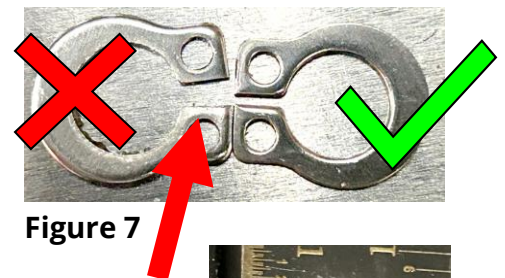
Ensure the grip ring is **NOT** deformed and loose on the shaft. It should fit tight into the groove. Figure 7 shows a deformed grip ring on the left and a normal grip ring on the right.

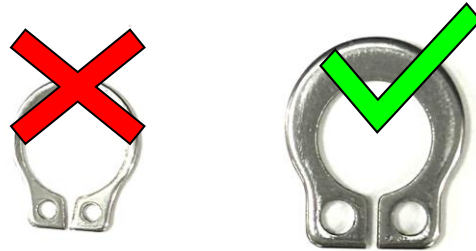
Figure 11

Standard snap rings **SHOULD NOT** be used (see snap ring on the left in Figure 11). They will not hold and will come loose.

ONLY HEAVY-DUTY GRIP RINGS from the manufacturer (see grip-ring on right in Figure 11) should be used.

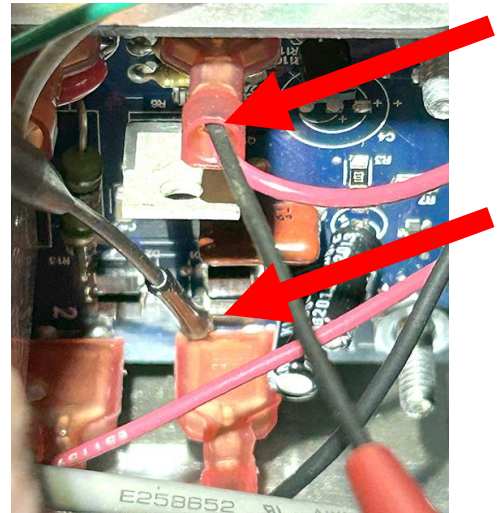
Figure 12

- i. Test across pins 1 (Red) & 12 (Black) (see Figures 12, 14 & 15). 24VDC should be present with the switch activated.
- ii. Test **across pins** 6 (Green) & 7 (White) or 2 & 3, depending which pins have Green and White wires attached (see Figures 13, 14 & 15). The voltage should be near 0VDC when activated. If the voltage is above 0.3VDC with power on and contacts closed, the time delay relay **MUST** be replaced.
