Service Bulletin

Subject: Incorrect Set Dip Switches

Models: Frymaster, Merco, McDonald's UHCTHD
New UX Touch Screen Controllers

6/12/2026

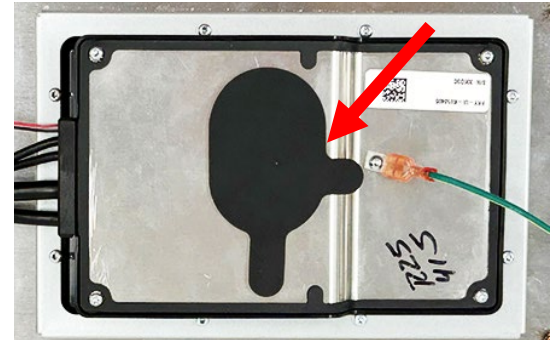
Figure 1

Some new style service replacement touch screens were shipped from May 25, 2026, through June 5, 2026 with dip switches set incorrectly. This **ONLY** affects the new style touch screens shown in Figure 1.

The new style touch screens can be quickly identified by looking at the rear of the touch screen controller (see Figure 1). The prominent feature is the rubber SD card/dip switch access cover that can be removed to access the dip switches.

When replacing a new style touch screen on a McDonald's UHCTHD, Merco Holding Cabinet or Frymaster fryer, perform a quick inspection of the dip switch positions to ensure they are in the proper position. If the touch screen dip switches are in the incorrect position, the controller may not boot up properly or may not operate properly.
