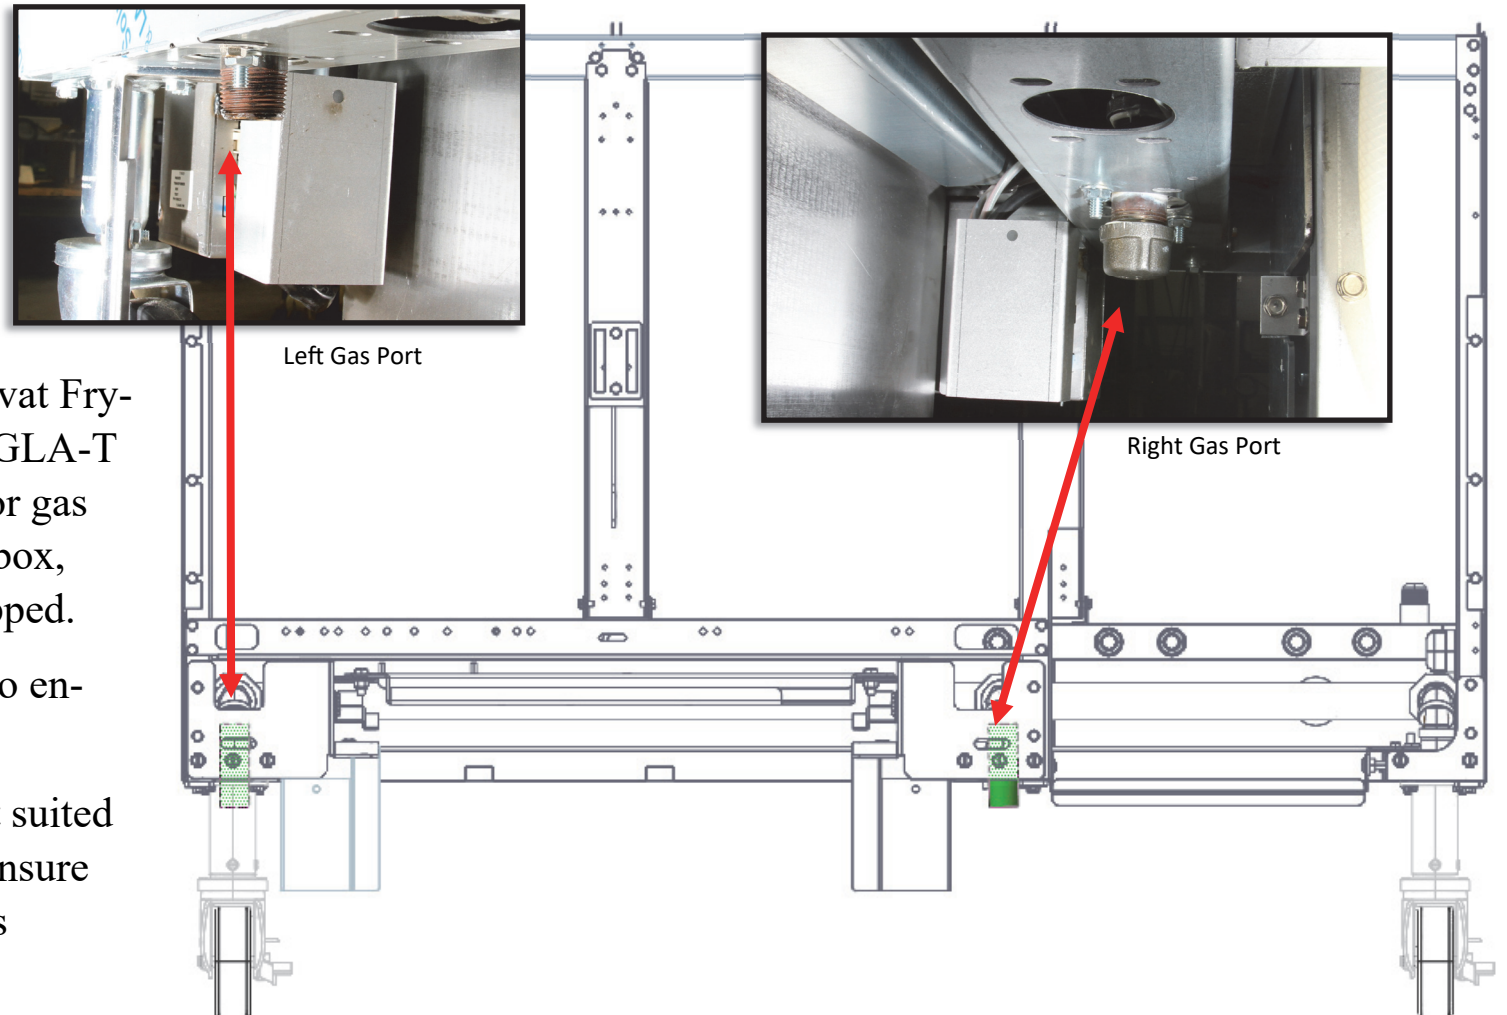
Two, three and four-vat Frymaster McDonald's BIGLA-T fryers have two ports for gas connection. Out of the box, they should both be capped.

Inspect a new fryer to ensure both are capped.

Remove the cap best suited to the installation and ensure the unused port remains capped.
