# Vertical Toaster Retrofit Kit 826-1567

Vertical Toaster kit 826-1567 should be installed on any toaster built prior to series AD. This kit includes new bushings for the upper rollers, springs, bushing-lock clips and assorted minor hardware. The servicer should also have on hand drive rollers, a motor and lower bushings (see chart at left) and replace these parts as necessary.

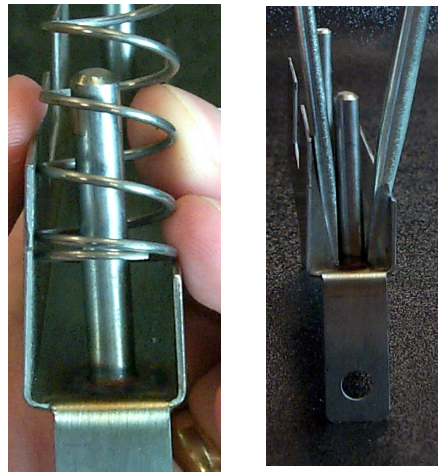
The new springs should fit so loosely in the plunger that they fall out if inverted. If they catch in the assembly (left), use screwdrivers (right) to widen the opening until the springs fall freely from the assembly.

**Note:** The new springs are longer and larger in diameter than the originals. It is critical to check that they fit loosely in the plunger assembly. The inserted springs should fall freely from the assembly when the assembly is inverted. If a spring fails this test, use a pair of screwdrivers to widen the opening.

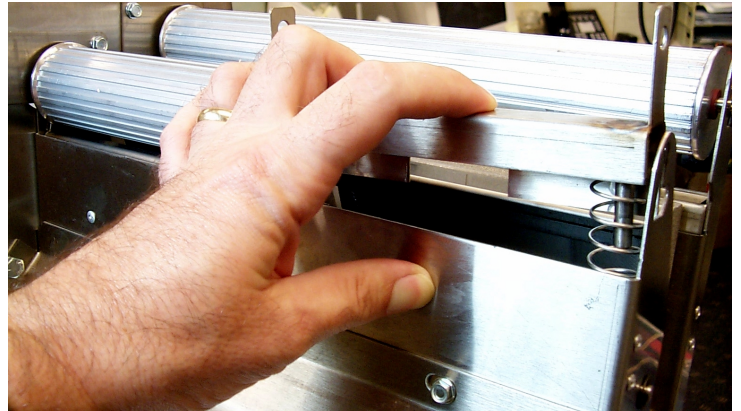
The plunger that carries an upper roller is returned to the toaster.

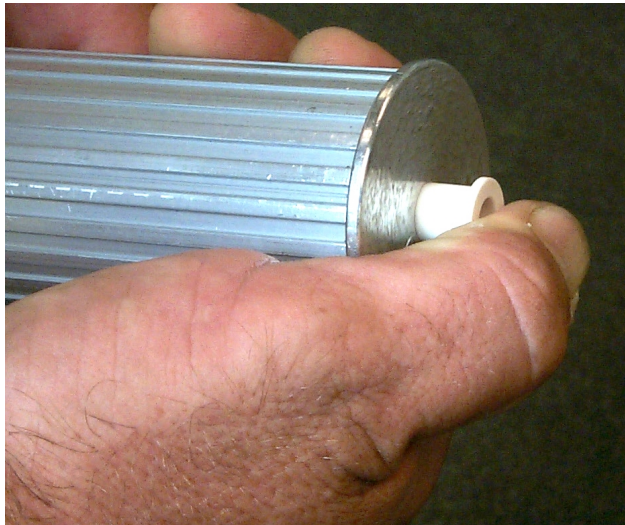
A new white bushing is pressed into a roller.

- Replace original red bushings with white bushings provided in kit. **See Photo.**
- With rollers removed, the springs under the front rollers are easily accessed. Simply lift plunger that holds roller. Inspect plunger for debris. Clean and deburr if necessary.

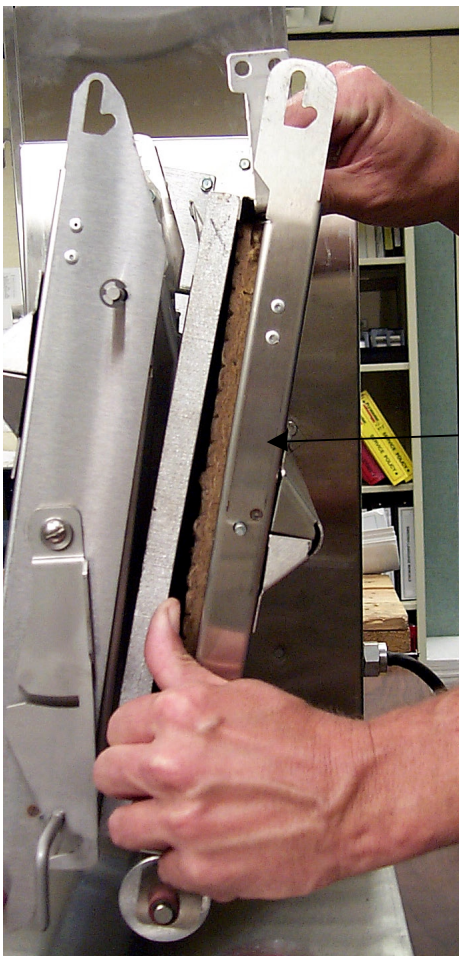
After removing the screws that attach the platen to the rear toasting conveyor, the platen can be displaced slightly to allow removal of the spring plunger. The outside plunger is removed first.

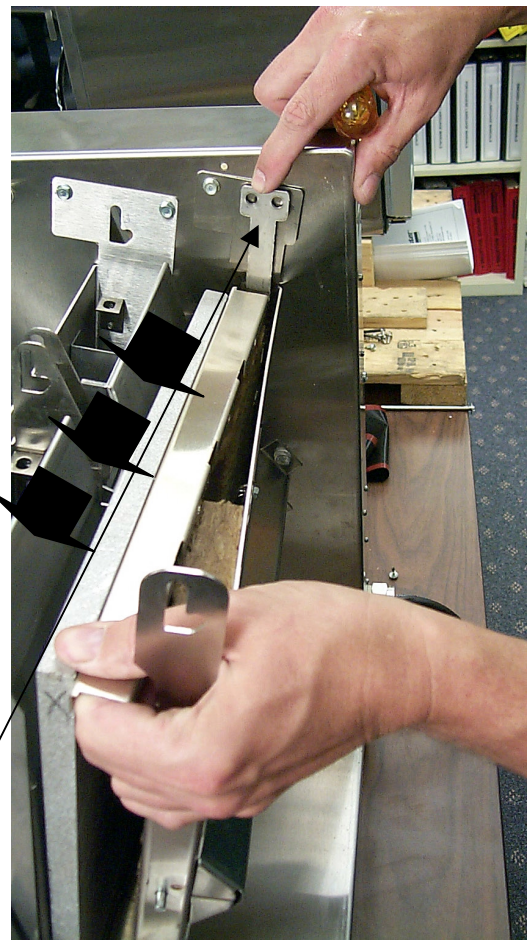
The inner plunger is removed after the platen is shifted slightly out from the conveyor assembly and away from the control housing.

- Work platen assembly slightly outward and remove outer plunger.
- Pull platen gently away from the control housing until the leads clear. Remove inner plunger.

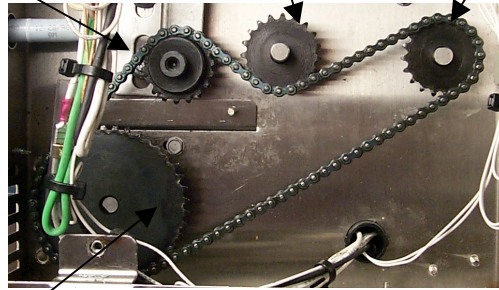
Idler gear      Rear drive roller sprocket      Front drive roller sprocket

The first step in accessing the drive rollers is removal of the roller sprockets. Here's a view of the drive train (with the vertical cabinet brace removed) for use in identifying the relevant parts.

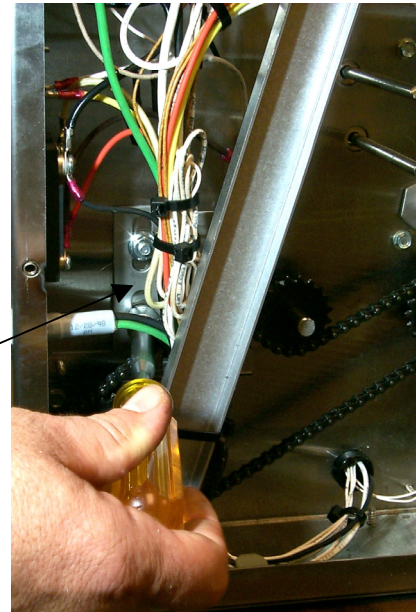
Drive sprocket

Loosen bracket holding idler sprocket. Lower bracket to release tension on the chain.

- With the side panel still off, loosen the idler sprocket assembly and slide it to the bottom. This creates maximum slack in the chain.
- Remove the chain from the rear roller sprocket, then the front sprocket.
- Loosen the two setscrews that secure the small sprockets to the drive roller shafts. Remove sprockets from shafts.

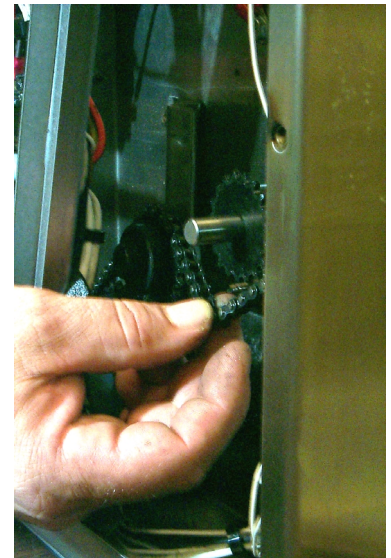
Remove chain from rear-roller sprocket. Note the chain runs on the underside of this sprocket.

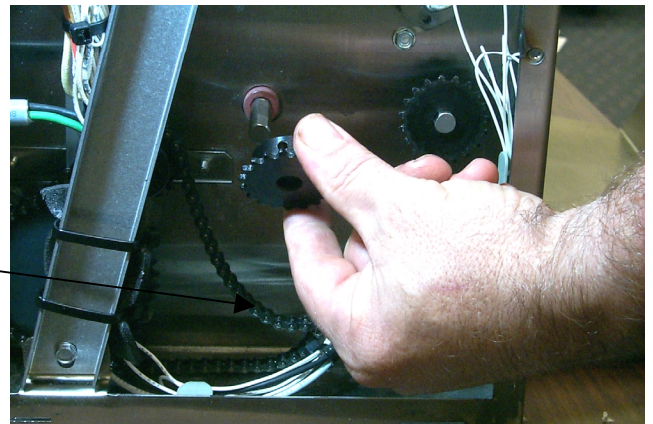
The sprockets are held on with setscrews. Remove setscrews with appropriate allen wrench and then remove sprockets.

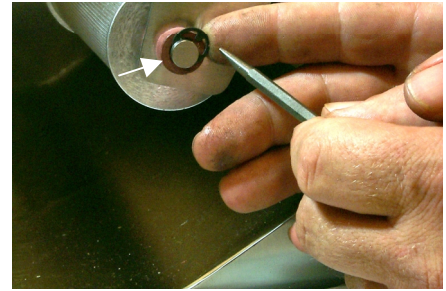
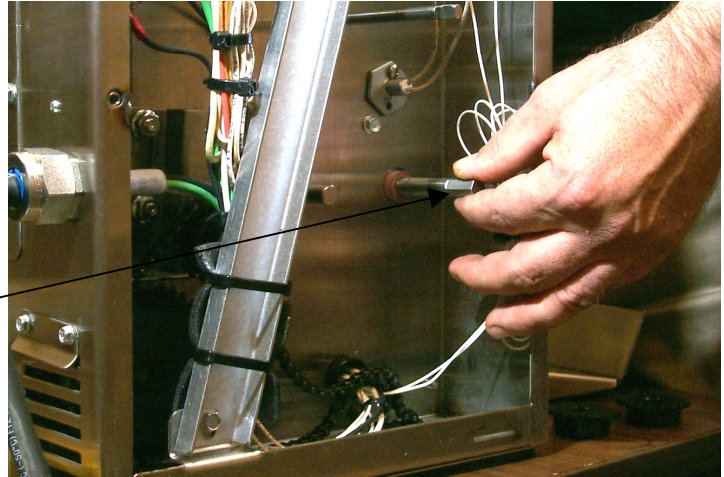
The drive rollers are held on with E-clips on the side opposite the drive sprockets. Use a flat-blade screwdriver to remove E-clips.

Pull the roller axle out slightly on the drive-sprocket side. This allows the roller to slip clear of the bushing on the opposite side. The axles are not removable from the rollers.

- On the opposite end of both roller shafts, remove the E-clips.
- Pull drive shaft on sprocket end until shaft clears bushing on E-clip end of roller.
- Lower the E-clip end of the roller assembly and remove the roller from the unit.
- Repeat process for other roller.
- Remove the front roller and then the rear roller.
- Remove roller bushings from toaster framework for installation of bushing clips.

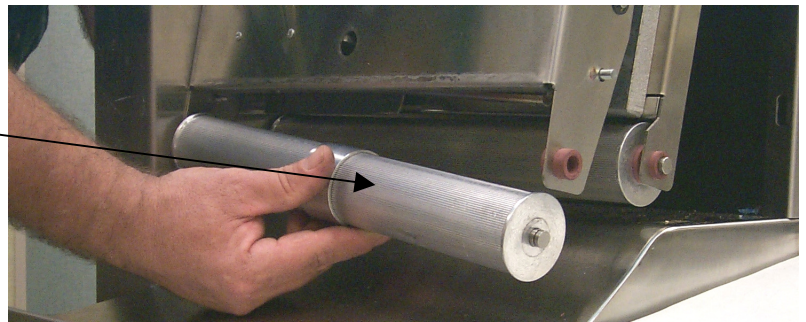
Examine splines on drive rollers for uniform ridges around the cylinder. There should be no flat or bare spots. The roller must have sufficient grip to pull the belts without slipping. Replace if needed.

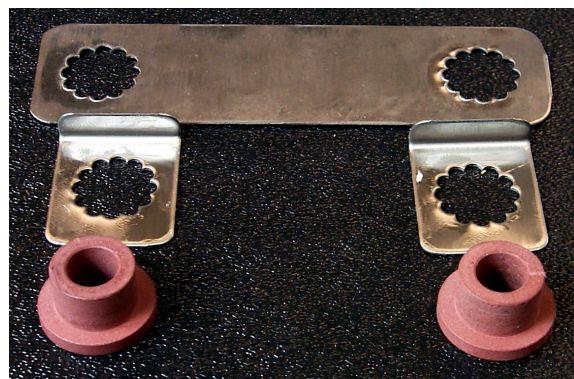
The kit includes two types of bushing clips. The dual (top of photo) fits inside the toaster cabinet on the controller side. The single fits on the opposite side of the drive roller. Replace existing bushings as necessary.

The existing lower roller bushings are pressed into the provided bushing clips, which have serrations to prevent the bushing from turning in the toaster's framework. Replace any bushing that has been damaged by rotation in the framework.

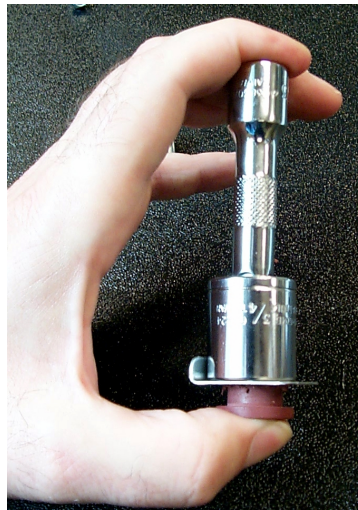
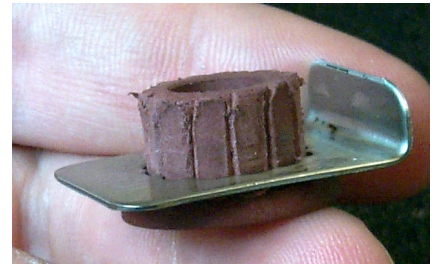
The bushing clips are pushed on (left) using a socket and extension. On the single clip, the flange side of the bushing (above) is pressed flush against the flat side of the clip.

- Remove red bushings from toaster framework. Inspect and replace any damaged bushings.
- Place the bushing on a firm, flat surface with the lip side down.
- Using an appropriately sized socket and drive extension, press the clip on to the bushing. Do the dual clip one side at a time.
- The single clips go on the side away from the controller, with the lip curling under the toaster framework to prevent rotation. **See photo below.**
- The dual clip mounts on the controller side of the cabinet. **See photo below.**
- Reinstall the rollers.

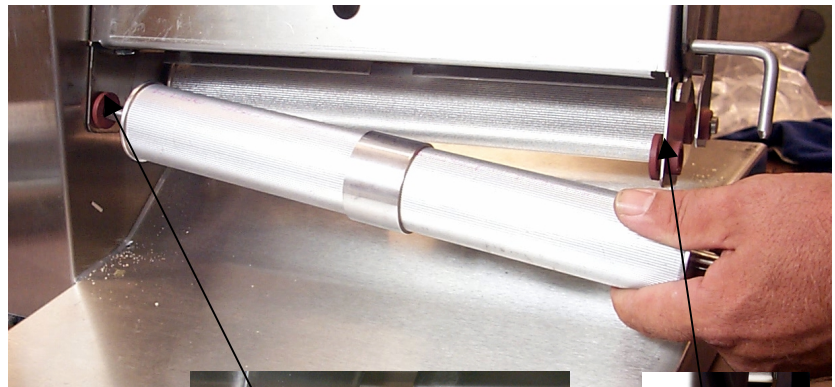
Note the drive roller with the spacer/ collar goes in the front position. The spacer separates the front belts.

The dual clip mounts above the heater tray (above) on the controller side of the unit. The bushings, with clip in place, are simply pressed into place prior to installing the drive roller. The single clips (right) mount with the lip curling under the toaster's framework.

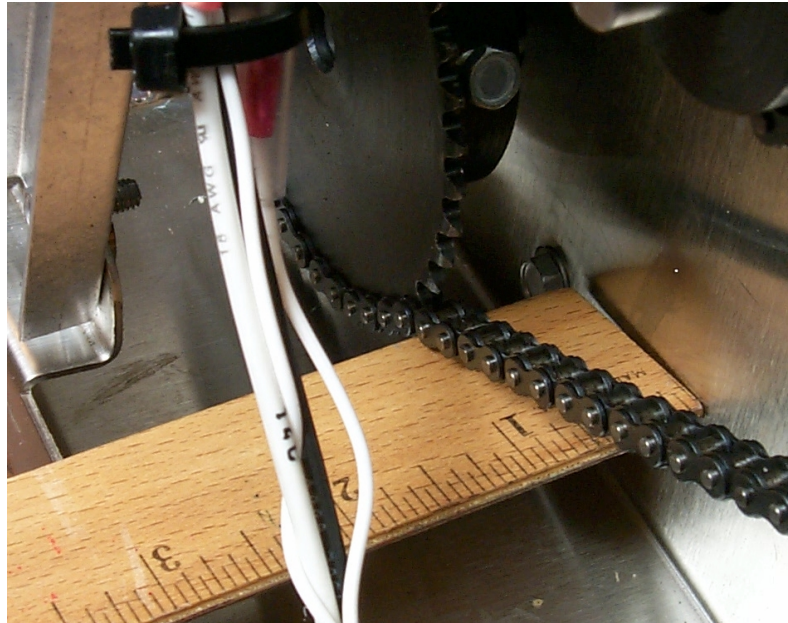
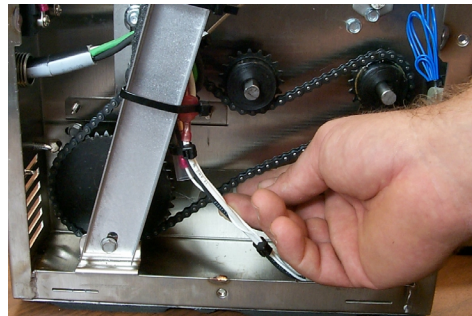
The drive sprockets should be aligned with the motor sprocket (above) to ensure the chain runs in a flat plane. The chain tension (left) should allow  $\frac{1}{4}$ " deflection from center.

- Replace drive sprockets. Ensure the chain travels in a flat plane. Use a ruler to ensure the drive-roller sprockets are set at the same depth as the drive sprocket.
- Use the idler to adjust the chain tension. There should be  $\frac{1}{4}$ " deflection from center with about two pounds of force applied.
- With rollers in place and the side panel off, run the unit to ensure correct tracking of the chain. Misaligned sprockets will cause the chain to pop. Correct as necessary.
- Listen carefully to the motor. If it makes an erratic or grinding noise, replace it.

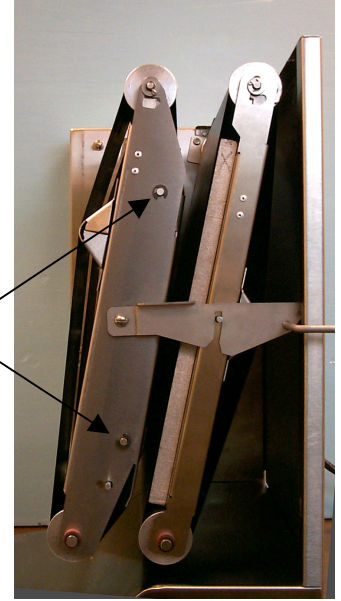
The E-clips that secure the cam assembly can be loosened or knocked out by the rotation of the latch. Ensure E-clips are properly placed. Replace if necessary.

- Check for missing E-clips on end of cam assemblies and replace as required.
- Replace the side panel and replace knobs. The setscrews in the knobs go to the flats on the compression setting shafts.
- Set knobs to 3 and C.
- Replace cover and put bun guide in place. Note: the insertion guides on the edges of the bun guide should angle in slightly.
- Put four sets of buns in the toaster, four crowns and four heels. The last heel should pass through the toaster in 13 seconds or less.

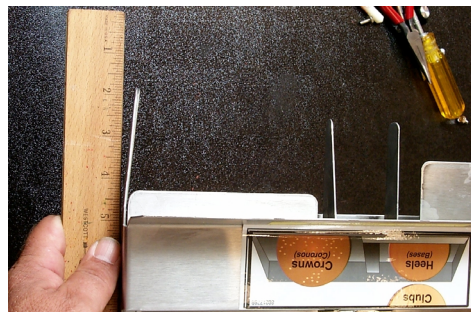
The insertion guides (left) on the bun guide should angle in slightly.
