LOV Gas ATO, AIF Probe Inspection

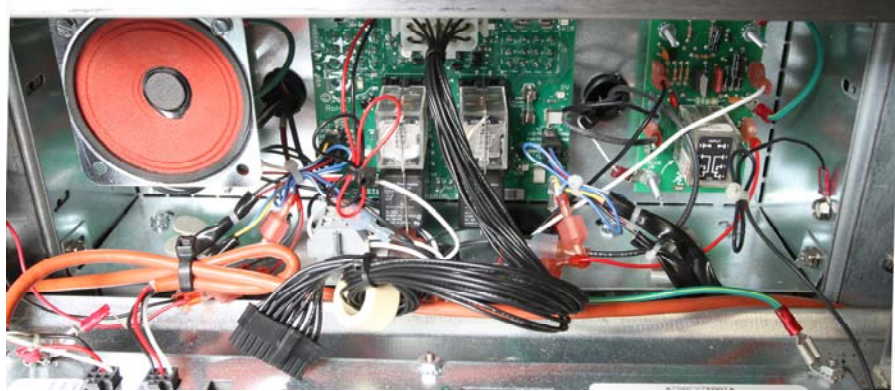
3. Remove ignition module covers.

4. Tighten the hi-limit and temperature probes.

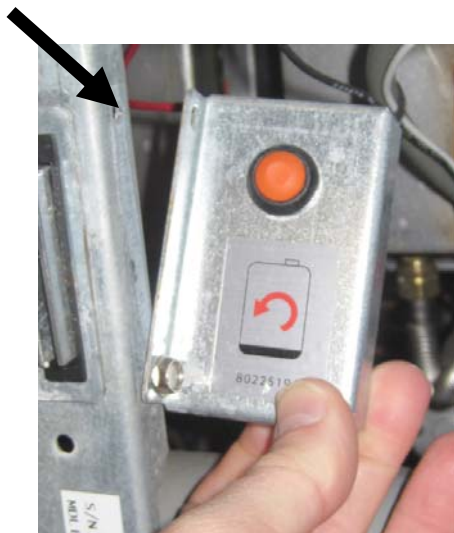
6. Remove the screws attaching the speakers to the frame and set inside the box.

7. Remove the 4 screws in the corners attaching the control box to the frame. Remove the screw attaching the locator wire and set aside.

NOTE: Locator wires are control box specific. Do NOT accidentally cross positions of locator wires between boxes.

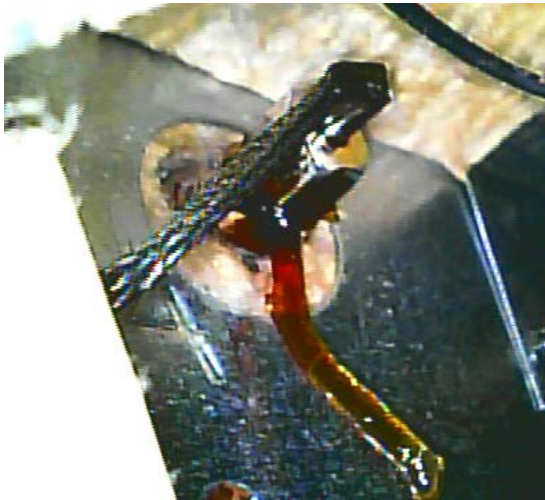
12. Tighten the compression nut, not the fitting. The nut should be tightened to approximately 8 foot pounds (finger tight plus one additional turn).

NOTE: Compression nuts with minor leaks (as shown above) will be corrected by tightening.

Frymaster needs a total count of leaking or weeping probes per bank of fryers.

If the surrounding insulation is saturated from the leak, the probe must be changed and the insulation replaced.
