# Service Bulletin

## Subject: Zone Low Temp Error Modification Thermal Cutout Switch

Models: Merco MHA, MHC, MHD, MHG, MHL, MHS,  
MHT Cabinets

9/22/2022

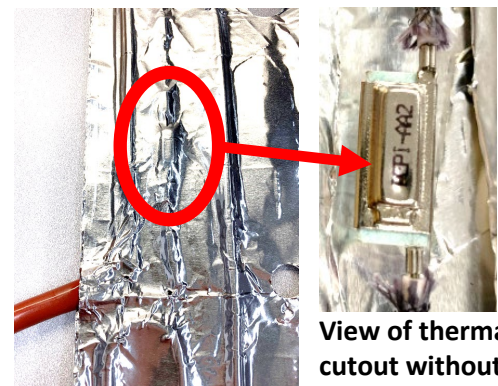
Figure 1

4. Remove power from the cabinet.
5. Locate the affected thermal cutout switch. It will be located near the exit point of the harness (see Figure 1).
6. Expose the thermal cutout switch by carefully cutting through the top layer of the foil tape (see Figures 2 and 3).

View of thermal cutout without heat shrink.

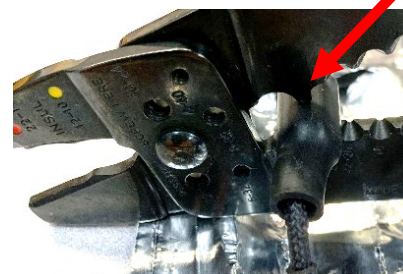
Figure 4

7. Position a crimping tool over the center of the thermal cutout switch. With light pressure, squeeze the crimping tool with the **sharp heel of the crimper** until an indentation is created. It is critical this performed this way and **NOT** with pliers or the blunt end of the crimpers. This will compress the **flat side** of the housing, preventing the contacts from opening the heater circuit (see Figures 4 and 5).

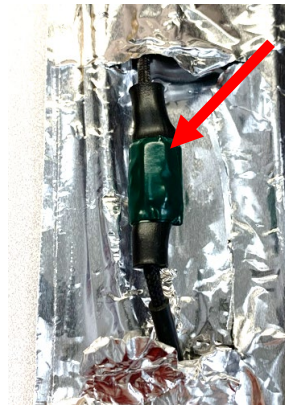
Figure 6

8. Wrap three (3) loops of electrical tape securely around the thermal cutout switch to ensure isolation (see Figure 6).
9. Cover the thermal cutout switch with foil tape (see Figure 7).
10. Reassemble and connect power to the cabinet.
11. Verify the specific zone is reaching set point.
