Identifying McDonald's Cap-N-Splash Hood Systems

Stand-off Boxes and Cap-N-Splash Hood Systems

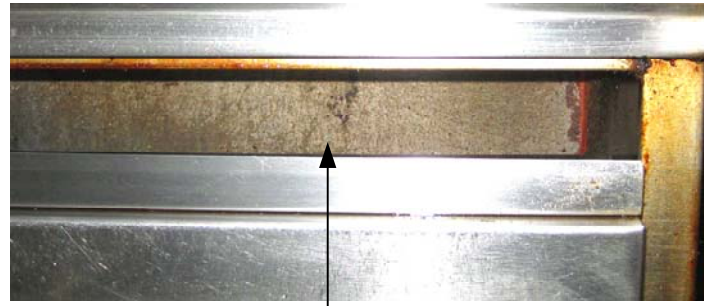
Gaps Cause Damage

McDonald's fryers installed in a cap-n-splash style hood must have a cap-n-splash lock-in device, which locks the fryer in place with the hood. Fryers placed in a cap-n-splash style hood without the special device will have a gap between the fryer and the hood (see above), which allows oil-laden air to rise behind the hood, escaping the filters and the drip trough. Oil accumulates in the hood and drips down, ruining the oil and damaging fryer components.

DO NOT install a fryer with a gap, similar to the one shown above.

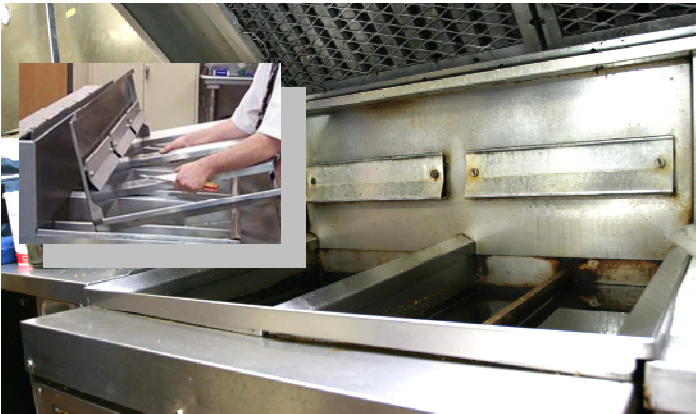
Cap-N-Splash Visual Cues

The cap-n-splash is levered onto the fryer (see inset). The interior ribs replace the joiner strips and the upper edge is captured by the hood.

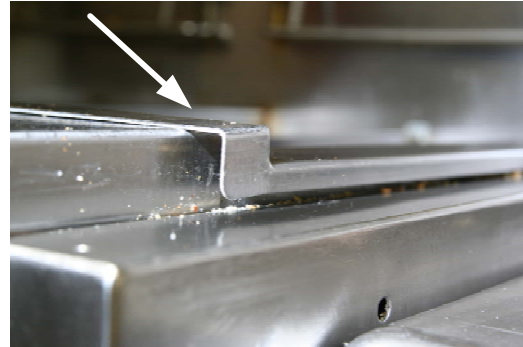
With the fryer in the hood, there are many visual cues to the presence of the cap-n-splash. A prominent lip, sometimes slightly raised, around the frypots is a clue.

If the fryer is removed before the installation of a new fryer, the cap-n-splash hoods can sometimes be identified by embedded controls as seen here. And there is the gap between the new fryer and the hood (shown above).

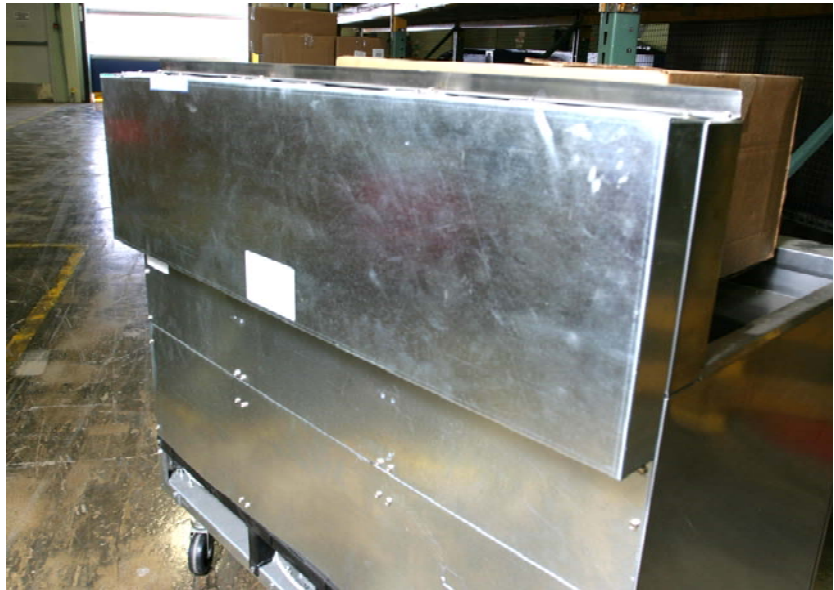
Frymaster's gas fryers for McDonald's are sold with a stand-off box attached to the back (see photo at right). It is necessary for the fryer to be properly fitted under a universal hood. The stand-off doesn't work under a cap-n-splash style hood and must be removed to achieve a proper fit. Wall-mounted stand-off channels fill the role of the stand-off box in cap-n-splash hood systems.

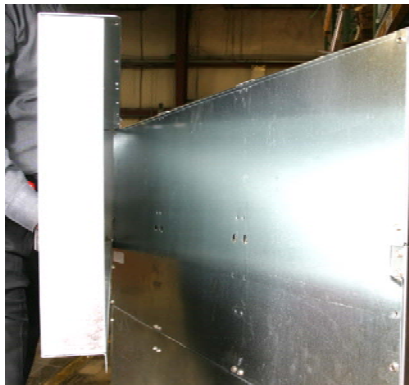
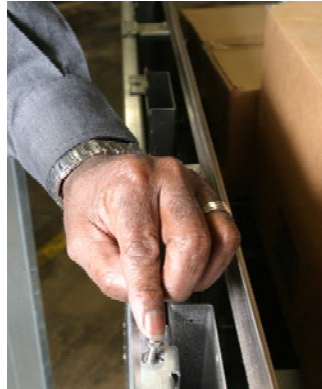
The stand-off is held in place with sheet-metal screws and easily removed (left above). The screws securing the flue (right above) must be replaced.
