## Service Bulletin

**Subject: Pre-Filter O-Rings**

**Models: Frymaster Touch Screen Fryers LOV (BIELA14-T, BIGLA30-T), FilterQuick (FQ30/60/80/100/120) SN 2301 through 2401**

**01/25/2024**

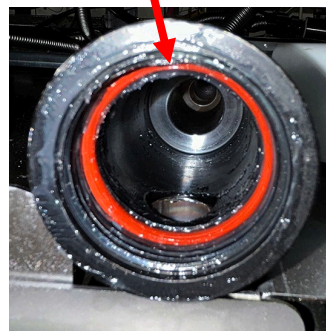
**Figure 3** O-Ring installed

An O-ring should be visible inside the pre-filter housing (see Figure 3).

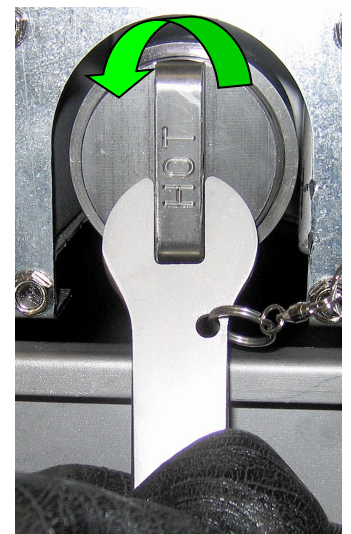
**Figure 4**

Wearing protective gloves, remove the pre-filter using the attached wrench (see Figure 4), rotating the pre-filter counter counter-clockwise.
