Service Bulletin

Subject: McDonald's Intuition MIE314 Cord set Impingement

Models: Frymaster McDonald's MIE314 Intuition Electric Fryers with serial numbers prior to 2610.

10/1/2026

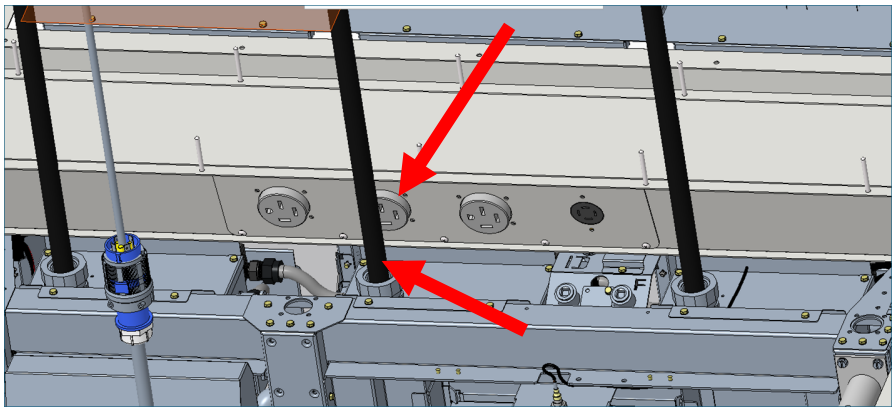
Figure 1

Some McDonald's MIE314 Intuition electric fryers middle cord position, may interfere with the receptacle on the race way, that **use universal hoods** (see Figure 1).
