Instruction Sheet

Subject: Software Update, Sediment Tray Removal, Basket Support Rack Installation and OIB plug Inspection Instructions

Models affected: Taco Bell FilterQuick Touch Gas Fryers (FQG30-T)

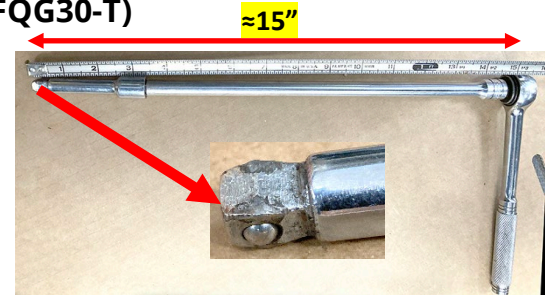
Figure 1

NOTE: Prior to starting, you MUST HAVE a 3/8" square tapered wobble extension (see Figure 1), with 15" of extensions, to perform this task. A universal joint WILL NOT work.

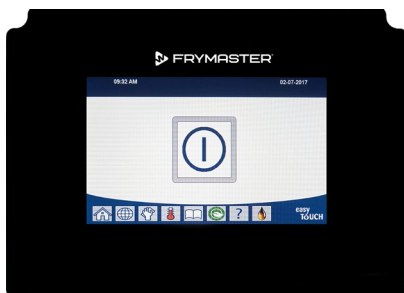
Figure 10 - Large Black Surround Controller

If the controller matches the photo in Figure 10, with the large plastic surround, use the **BLUE** USB shown in Figure 11.

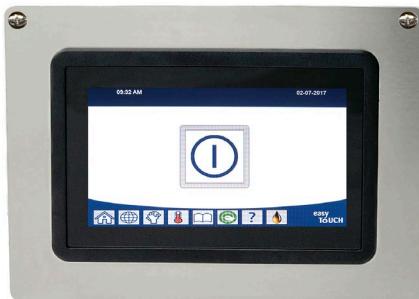
Figure 12 - Large Metal Silver Surround Controller

If the controller matches the photo in Figure 12, with the large metal silver surround, use the **RED** USB shown in Figure 13.
