## Instruction Sheet

**Subject: Software Update, Sediment Tray Removal, Basket Support Rack Installation and OIB plug Inspection Instructions**

**Models affected: Taco Bell FilterQuick Touch Gas Fryers (FQG30-T)**

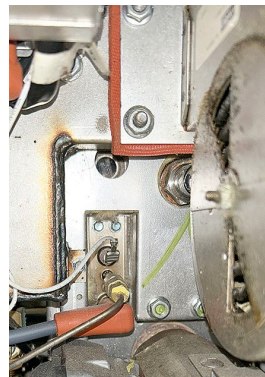
Figure 6

- c. Photo above the blower showing around the OIB plug (see Figure 5). Get an unobstructed view. If there's any leakage, ensure that it is shown.
  - d. Photo below the blower showing a close-up of the ignitor area (see Figure 6).
  - e. Photo of rating plate, inside adjacent frypot door with serial # (see example Figure 7).
4. Examine the OIB plug and compare the plug and ignitor to photos in Figures A thru E for remedy instructions.
