Service Bulletin

Subject: UHCTHD Communication/Configuration Errors

Models: McDonald's UHCTHD Touch Screen Holding Cabinets

9.23.24

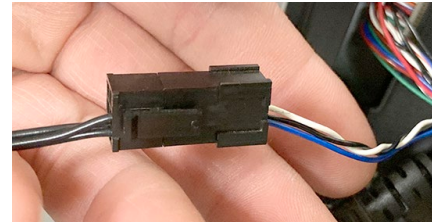
Figure 1

- 2) If the CAN connections between the rear touch screen and the front touch screen 6-pin blue and white wires (see Figure 1) have been disconnected and reconnected, and no pins on any of the connections have been pushed out of the connections then proceed.
