Service Bulletin

Subject: Float Switch Clip, Float Inspections & Troubleshooting

Models: FQG60T, FQG80T, FQG100T & FQG120T Touch Screen Fryers

7/16/2025

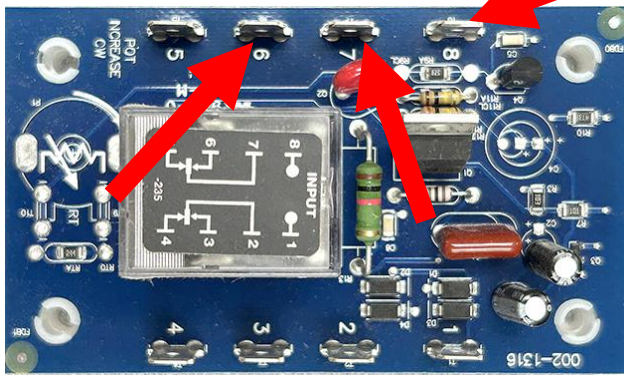
Figure 14

- i. Test across pins 1 (Red) & 12 (Black) (see Figures 12, 14 & 15). 24VDC should be present with the switch activated.
- ii. Test **across pins** 6 (Green) & 7 (White) or 2 & 3, depending which pins have Green and White wires attached (see Figures 13, 14 & 15). The voltage should be near 0VDC when activated. If the voltage is above 0.3VDC with power on and contacts closed, the time delay relay **MUST** be replaced.
