LOV-T Software Update Instructions

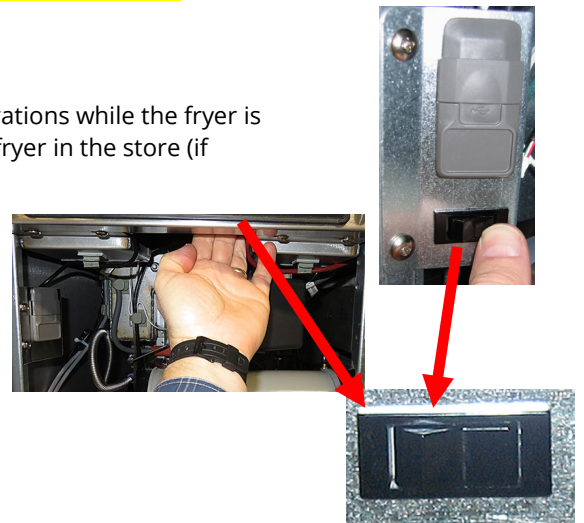
To power cycle the system, **PUSH and HOLD** the black toggle reset switch for **60 SECONDS**. The reset switch is located either under the USB port, near the USB port or under the left control box (see photos to the right). If the switch is not accessible, unplug the fryer or turn off the breaker to the fryer.

- Power cycle the system as shown in Step 2 on the first page. **ENSURE THE SWITCH IS PRESSED AND HELD FOR 60 SECONDS.** Failure to press and hold the reset switch long enough, may cause an incomplete software update.

1. Power cycle the system one more time as shown in Step 2 on page 1. **ENSURE THE SWITCH IS PRESSED AND HELD FOR 60 SECONDS.** Failure to press and hold the reset switch long enough, may cause an incomplete software update.
