Updating the Software on Your Touchscreen Fryer

8 1 9 7 4 6 7
4/05/2023

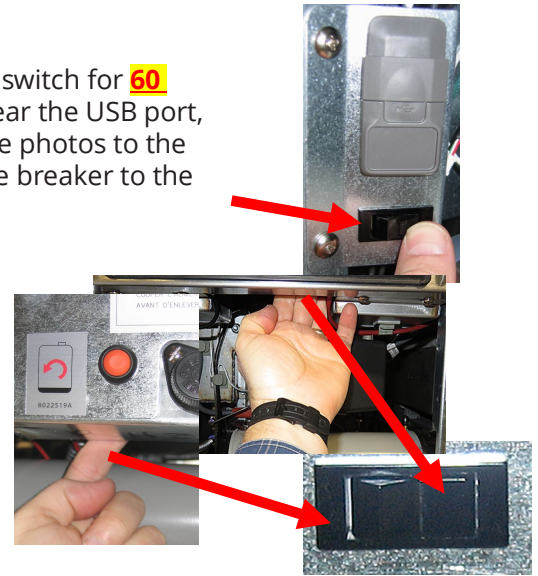
To power cycle the system, **PUSH and HOLD** the black toggle reset switch for **60 SECONDS**. The reset switch is located either under the USB port, near the USB port, under the left control box or directly behind the JIB reset switch (see photos to the right). If the switch is not accessible, unplug the fryer or turn off the breaker to the fryer.

- Power cycle the system as shown in step 2 for **60 SECONDS.** Failure to press and hold the reset switch long enough, may cause an incomplete software update.

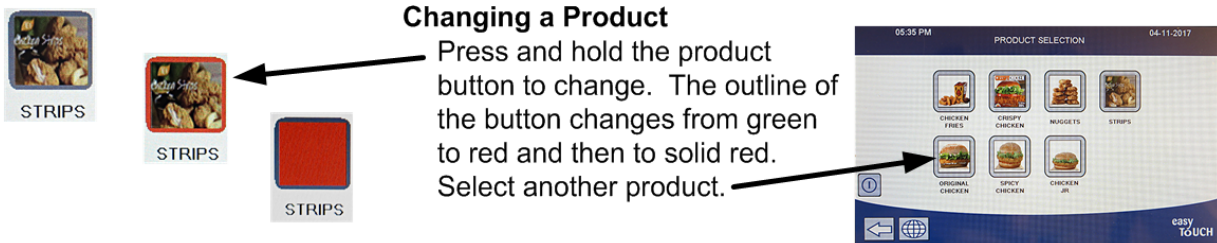
1. Power on all controllers.
2. Wait for all vats to heat to setpoint and all product images are displayed.
3. Press the menu button to advance from ALL RECIPES to BREAKFAST to LUNCH to CHANGEOVER.
4. Ensure products and images are in each menu.
5. If any current products or LTO (Limited Time Offers) are missing from menus, the products will need assigned to a location. Some products may need reprogrammed into each controller, as they may have been overwritten during the update.
6. Follow the instructions below to change product location assignment.
