LOV-T Software Update Instructions KOREA

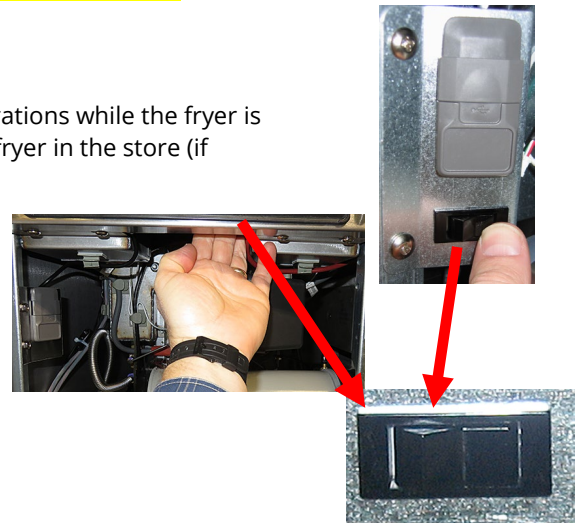
To power cycle the system, **PUSH and HOLD** the black toggle reset switch for **60 SECONDS**. The reset switch is located either under the USB port, near the USB port or under the left control box (see photos to the right). If the switch is not accessible, unplug the fryer or turn off the breaker to the fryer.

- Power cycle the system as shown in Step 2 on the first page. **ENSURE THE SWITCH IS PRESSED AND HELD FOR 60 SECONDS.** Failure to press and hold the reset switch long enough, may cause an incomplete software update.

1. Power cycle the system one more time as shown in Step 2 on page 1. **ENSURE THE SWITCH IS PRESSED AND HELD FOR 60 SECONDS.** Failure to press and hold the reset switch long enough, may cause an incomplete software update.
