## Instruction Sheet

**Subject: 8263742 7-11 FQ4000 Control Products to Jabil Common Controller Replacement Instructions**

**Models affected: FQE80T Touch Fryers**

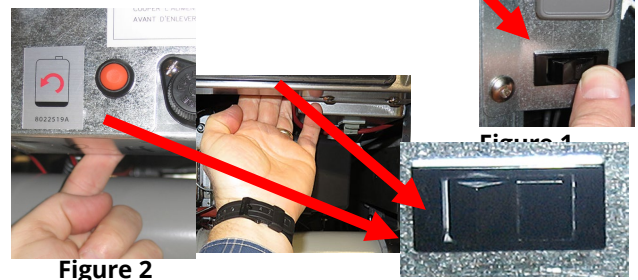
To power cycle the system, **PUSH and HOLD** the black toggle reset switch for **60 SECONDS**. The reset switch is located either under the USB port, near the USB port or under the left control box (see Figures 1 through 3). If the switch is not accessible, unplug the fryer or turn off the breaker to the fryer.

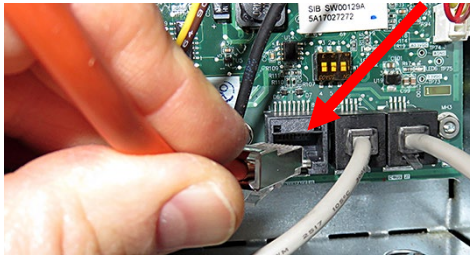
Figure 15

- Disconnect the RJ45 cable from the SIB board FIRST (see Figure 15).**

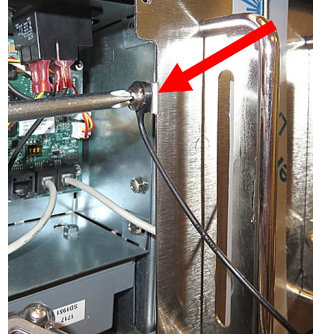
Figure 17

- Disconnect the lanyard tether from the frame (see Figure 17) to remove the controller.

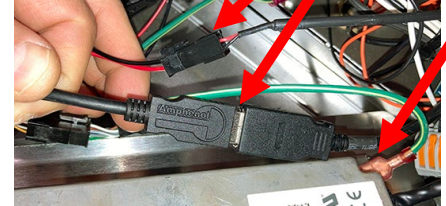
Figure 19

- Attach the speaker wire, the ground wire and the USB with the sleeve to the USB extension, if the controller is in the far-left position on the fryer (see Figure 19).

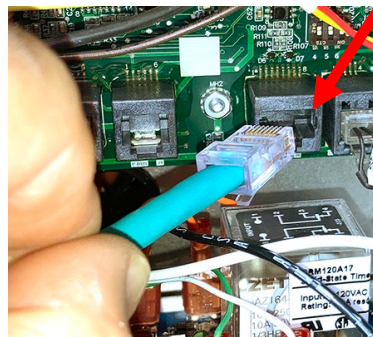
Figure 21

- Attach the RJ45 cable to the SIB board (see Figure 21).
