GM SW Update Instructions

## Updating the Software on Your Touchscreen Fryer

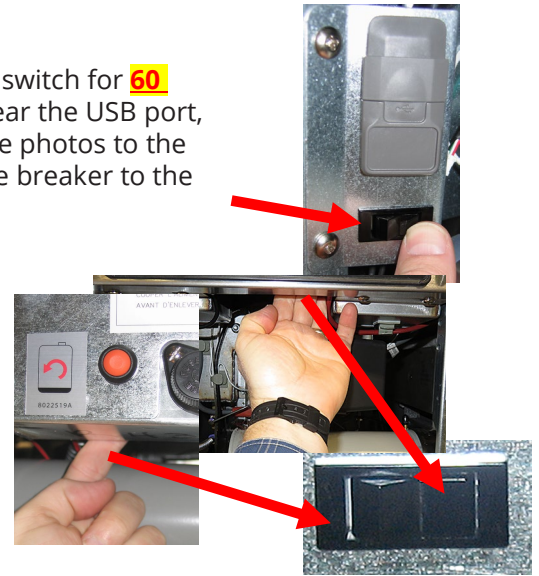
To power cycle the system, **PUSH and HOLD** the black toggle reset switch for **60 SECONDS**. The reset switch is located either under the USB port, near the USB port, under the left control box or directly behind the JIB reset switch (see photos to the right). If the switch is not accessible, unplug the fryer or turn off the breaker to the fryer.

- Power cycle the system as shown in step 2 for **60 SECONDS.** Failure to press and hold the reset switch long enough, may cause an incomplete software update.
