Instruction Sheet

Subject: 8263463 Auto Reverse Basket Lift Retrofit Instructions

Models affected: FilterQuick (FQGLA-T and FQG30-T) Gas Fryers

Follow these instructions to install the auto reverse retrofit basket lift kit. This allows the basket lift, if it isn't in the fully down position within ten (10) seconds, to automatically reverse and raise.

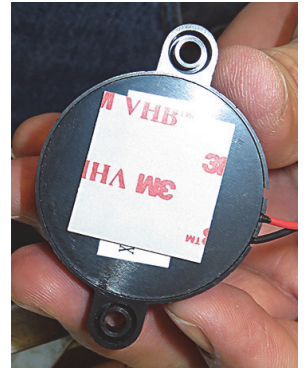
Figure 31

36. Apply VHB adhesive tape to the rear of the speaker (see Figure 31).
