Instruction Sheet

Subject: 8263468, 8263469, 8263470 SIB (Smart Interface Board) Replacement Instructions
Models affected: Japan LOV, FilterQuick Touch Fryers

McDonald's Japan LOV fryers manufactured prior to 10/31/2017 have SIB boards (1085979), that must be replaced prior to installation. Check the labels below before changing.

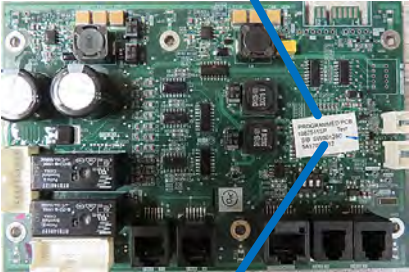
| BAD | Serial # 5A17034182 | |
| | Serial # 5A17034181 | |
| | SIB boards in this serial range MUST be replaced. | |

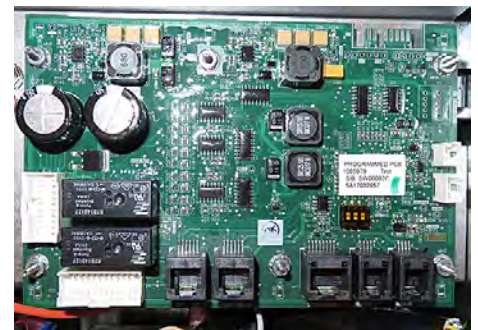
Figure 13

13. Disconnect the cables attached to the SIB board marking or making a note of the connectors to facilitate reconnection (see Figure 13).

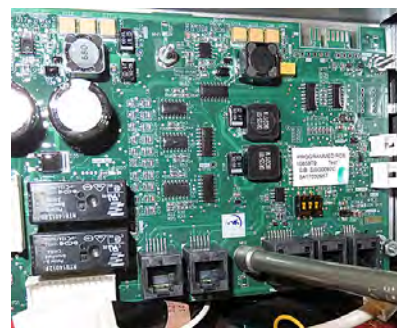
Figure 14

14. Remove the six 1/4" connecting nuts attaching the SIB board (see Figure 14).
