# BIGLA30-T Series

## Gen III LOV<sup>™</sup> Gas Fryer

### Service Manual

Part Number: FRY\_SM\_8197205 06/2017

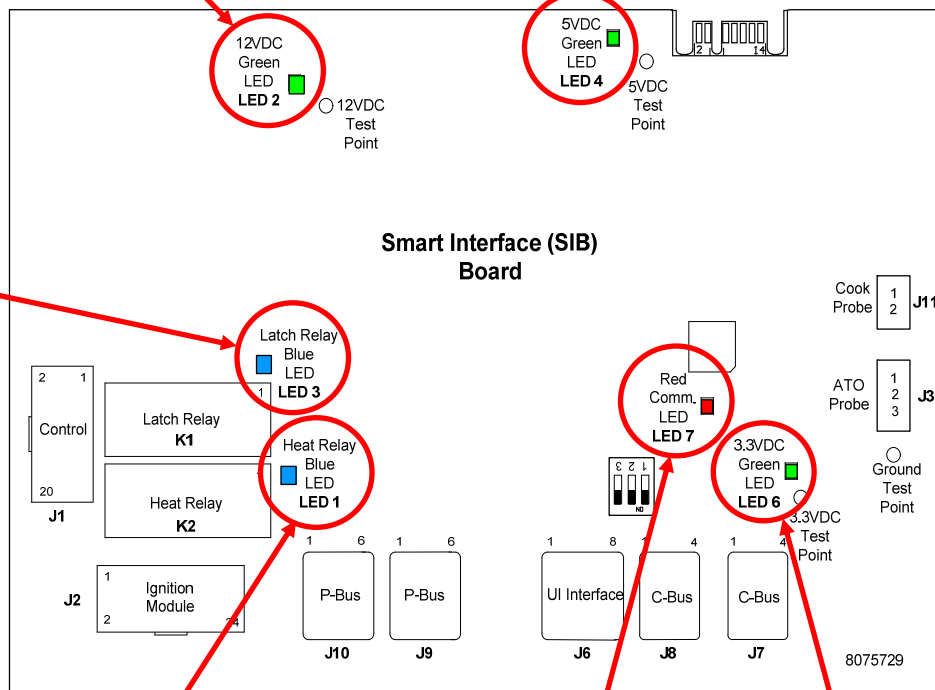
When UI is soft powered on this Latch Relay LED will come on first confirming high limit is closed. The blower will then come on and prove the air switch. The relay is a true latch circuit and when broken or turned off the heat relay will also turn off.

When UI calls for HEAT this LED will come on with the heat relay only after latch relay has been latched in and AIR switch has been proven. This LED will cycle with the call for heat.

Blinking red LED, (Heart Beat). This LED should be blinking and bright at all times when board is powered. The other green LED's being dim or off will cause this LED to be off.

3.3VDC LED should be lit and bright at all times. If dim then something is pulling voltage down. Short to ground on 3.3VDC circuit will cause dim LED.

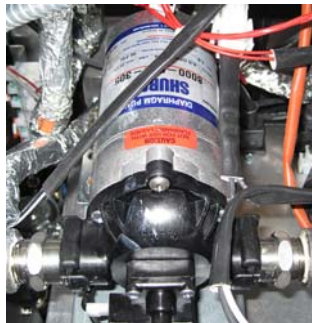
Figure 33

Disconnect the fryer from the electrical power supply. Locate the ATO pump (see Figure 33), behind the ATO box. Mark and unplug any wires or harnesses. Press down from the top on the quick disconnects to release the plumbing (see Figure 34). The plumbing can be pulled from the pump. Loosen the four nuts attaching the pump to the pump tray. Disconnect the electrical connection. Replace the defective component and reverse above steps. Once replaced, reconnect the power.

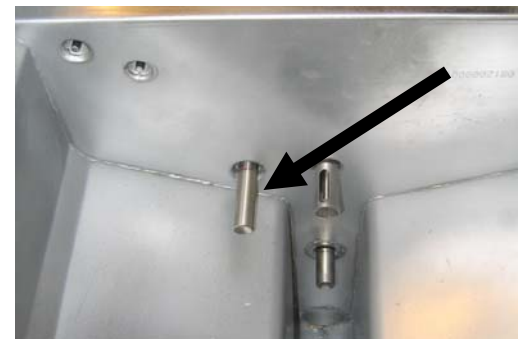
Figure 44

The oil level sensor is a device that is used to prevent dry firing of the frypot (see Figure 44). The sensor looks similar to a high limit sensor. The sensor is energized when the controller is powered on with a soft on. The sensor heats up and detects the oil around it. During filtration when the oil is drained, it senses the difference between the oil and air. It is controlled with a board located next to the interface board (see Figure 45) and a separate egg shaped plastic device (see Figure 46) that contains additional electronics. Use care when working with the sensor as temperatures may reach as high as 500°F (260°C).

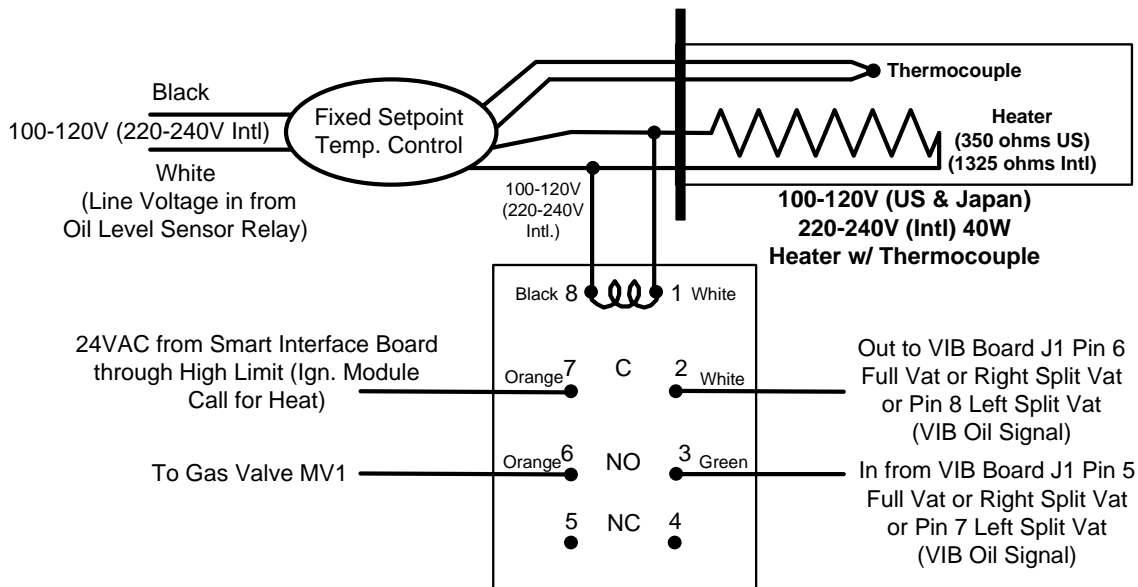
Time Delay Relay Board  
DPDT 7sec. Delay on Make  
Figure 47
