BIGLA30-T Series

Gen III LOV™ Gas Fryer

Service Manual

Part Number: FRY_SM_8197205 03/2017

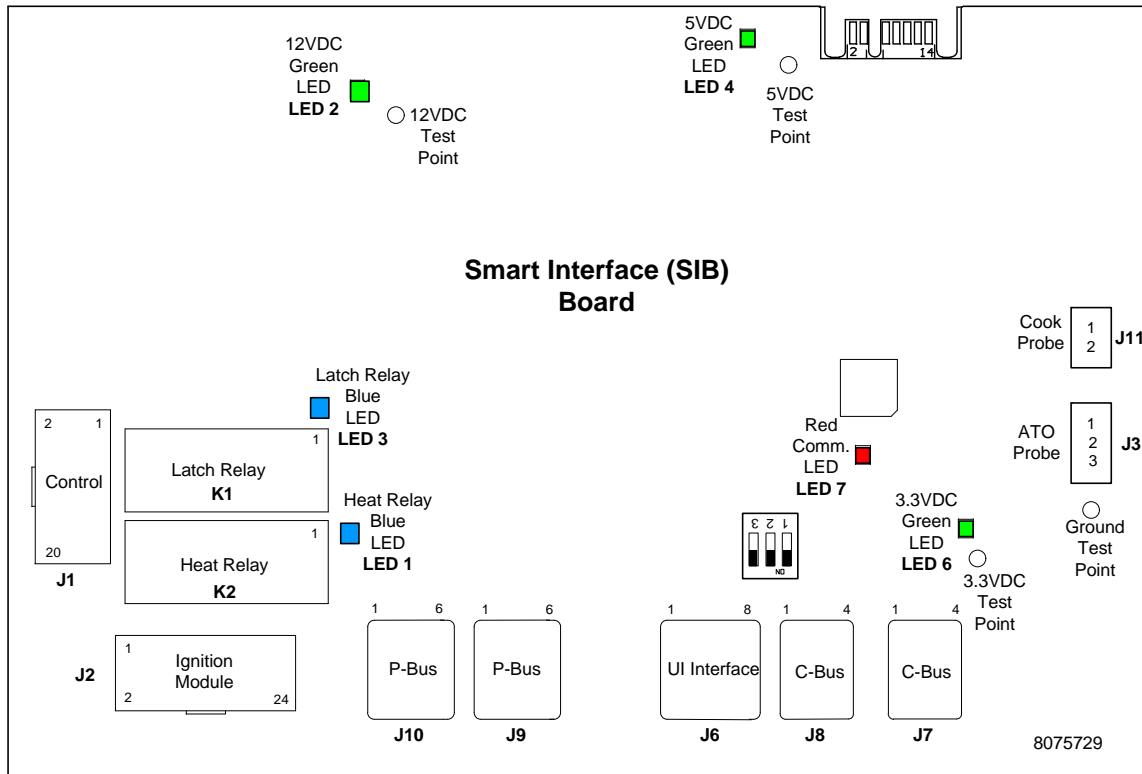
1.8 Smart Interface Board (SIB)

All fryers in this series have a smart interface board (SIB) located in the component box behind the controller panel. The SIB board provides a link between the controller and the fryer's individual components without requiring excessive wiring, and executes commands from one central point.

K2 is a single-pole-double throw (SPDT) relay that supplies 24VAC to the ignition and gas valve circuits. The relays on this board are soldered to the board. If a relay fails, the board must be replaced. K1 is a single-pole-double throw (SPDT) relay that supplies voltage through the high limit and the optional air pressure switch.

LEDs (labeled LED1 through LED7) are arrayed around the board to assist in troubleshooting.

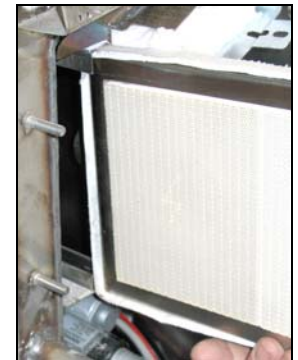
Figure 15

18. Carefully slide the replacement burner into the rails starting at the top and lifting slightly up on the bottom (see Figure 15). Ensure that the insulation is not torn or damaged.

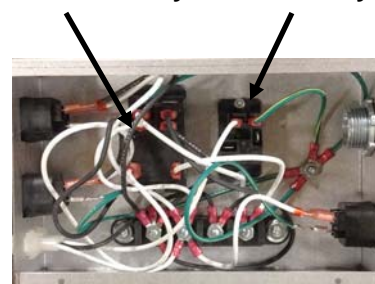
Figure 28

Power reset relay Hood Relay

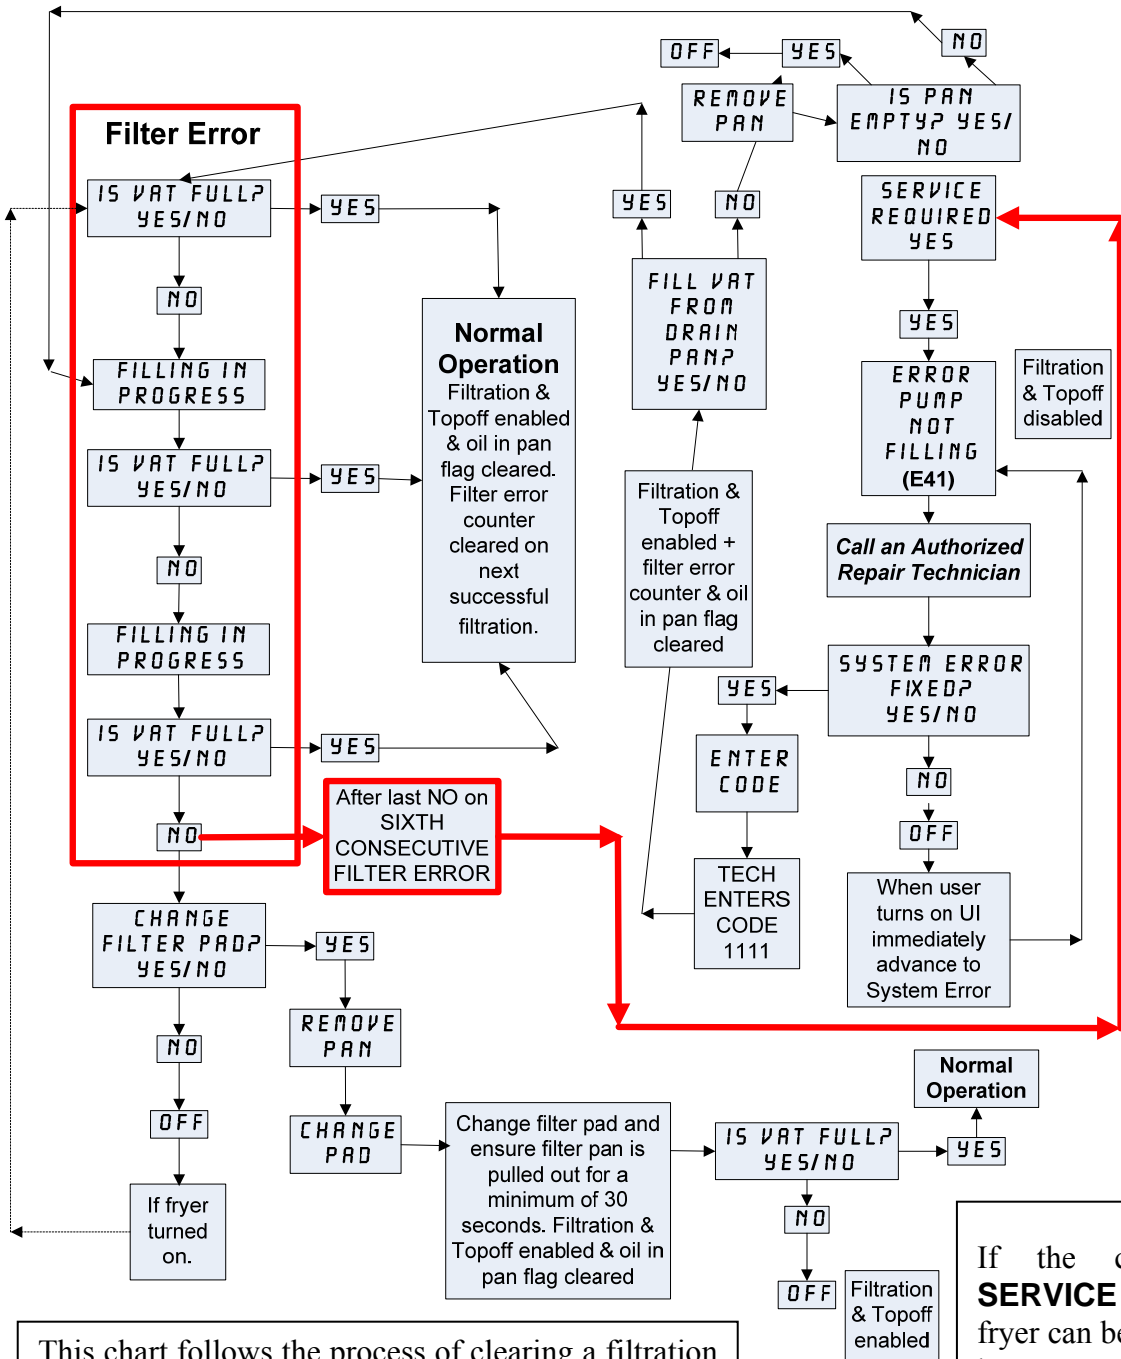
This flowchart is followed in all the places where the software displays "IS VAT FULL" except Maintenance filtration. In Maintenance filtration, "IS VAT FULL" message will be in a loop, until user press YES.
