# BIGLA30-T Series

## Gen III LOV™ Gas Fryer

### Service Manual

Part Number: FRY\_SM\_8197205 11/2017

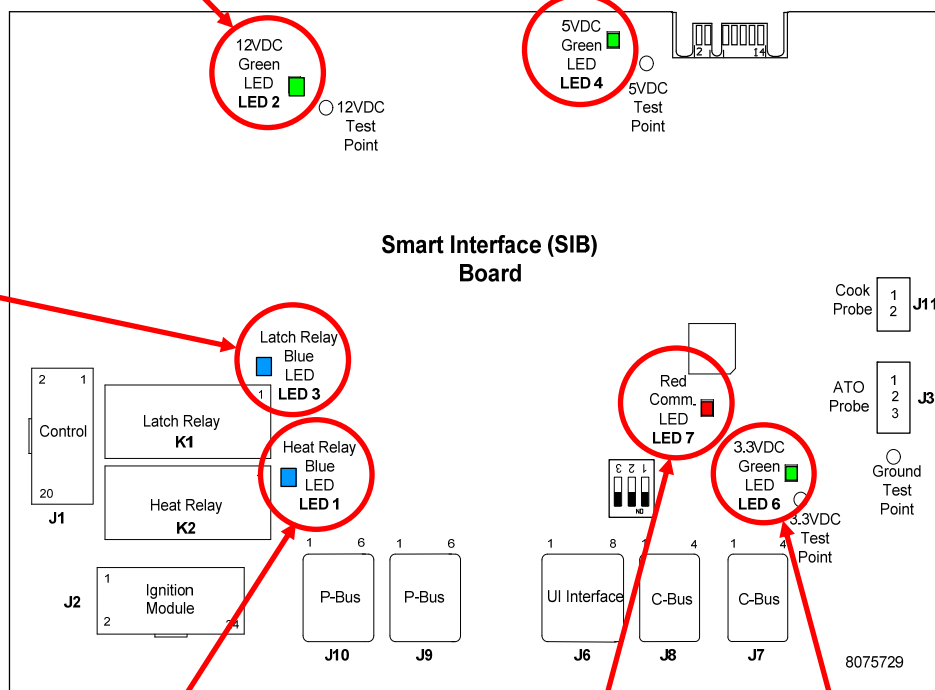
When UI is soft powered on this Latch Relay LED will come on first confirming high limit is closed. The blower will then come on and prove the air switch. The relay is a true latch circuit and when broken or turned off the heat relay will also turn off.

When UI calls for HEAT this LED will come on with the heat relay only after latch relay has been latched in and AIR switch has been proven. This LED will cycle with the call for heat.

Blinking red LED, (Heart Beat). This LED should be blinking and bright at all times when board is powered. The other green LED's being dim or off will cause this LED to be off.

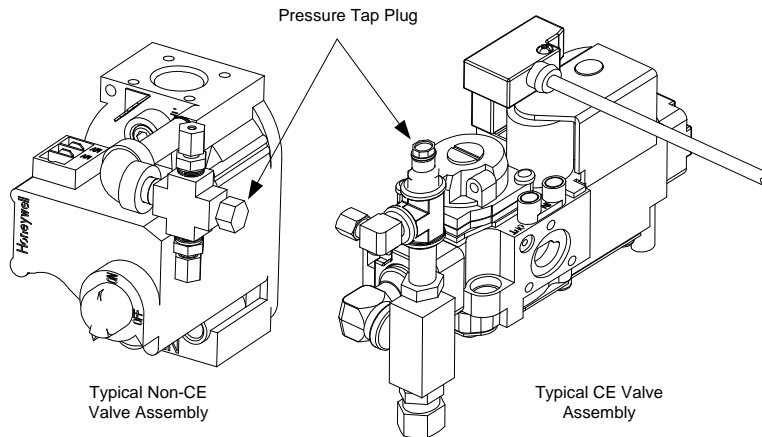
2. Remove the pressure tap plug from the gas valve assembly.

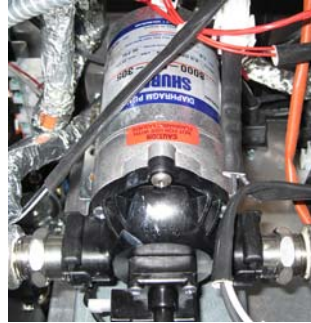
Figure 33

Disconnect the fryer from the electrical power supply. Locate the ATO pump (see Figure 33), behind the ATO box. Mark and unplug any wires or harnesses. Press down from the top on the quick disconnects to release the plumbing (see Figure 34). The plumbing can be pulled from the pump. Loosen the four nuts attaching the pump to the pump tray. Disconnect the electrical connection. Replace the defective component and reverse above steps. Once replaced, reconnect the power.

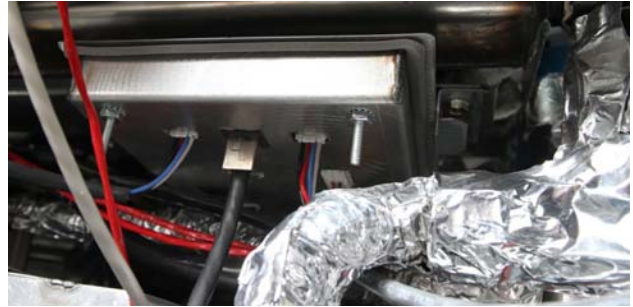
Figure 39

The VIB (Valve Interface Board) controls the actuators that open and close the drain and return valves. The VIB boards are located inside a protective housing under each frypot (see Figure 39).

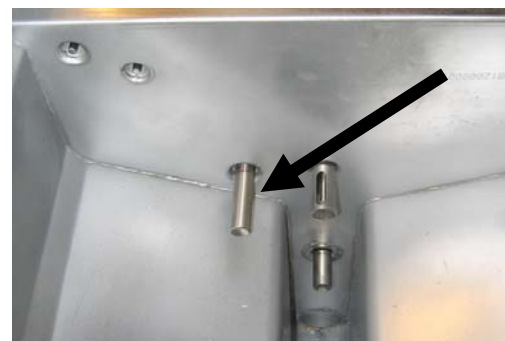
Figure 44

The oil level sensor is a device that is used to prevent dry firing of the frypot (see Figure 44). The sensor looks similar to a high limit sensor. The sensor is energized when the controller is powered on with a soft on. The sensor heats up and detects the oil around it. During filtration when the oil is drained, it senses the difference between the oil and air. It is controlled with a board located next to the interface board (see Figure 45) and a separate egg shaped plastic device (see Figure 46) that contains additional electronics. Use care when working with the sensor as temperatures may reach as high as 500°F (260°C).
