FilterQuick™ FQGLA-T

Gas Fryer

Service Manual

8 1 9 7 4 4 3
Part Number: FRY_SM_8197443 10/2017

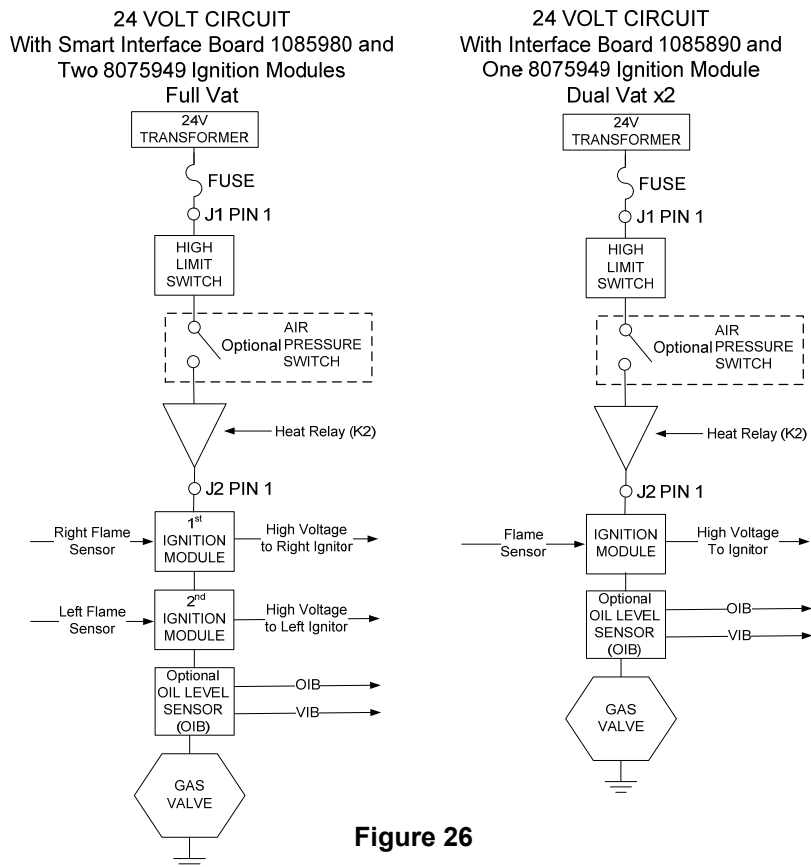
Figure 26

4. If LED 3 is not continually lit with the controller in the ON position, the probable cause is a defective latch relay.
 5. If LED 1 is not continually lit with the controller in the ON position and calling for heat, the probable cause is a defective heat relay.

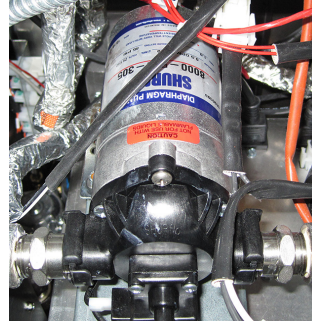
Figure 33

Disconnect the fryer from the electrical power supply. Locate the ATO pump (see Figure 33), behind the ATO box. Mark and unplug any wires or harnesses. Press down from the top on the quick disconnects to release the plumbing (see Figure 34). The plumbing can be pulled from the pump. Loosen the four nuts attaching the pump to the pump tray. Disconnect the electrical connection. Replace the defective component and reverse above steps. Once replaced, reconnect the power.

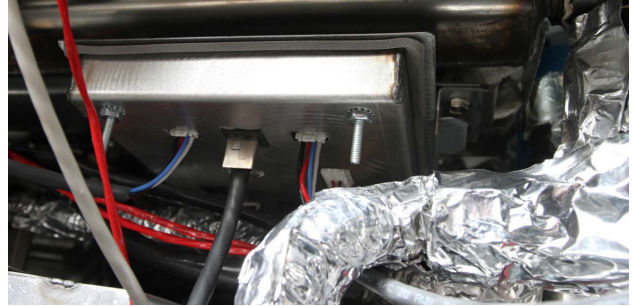
Figure 39

The VIB (Valve Interface Board) controls the actuators that open and close the drain and return valves. The VIB boards are located inside a protective housing under each frypot (see Figure 39).
