Frymaster®

BIGLA30-T Series

Gen IV LOV™ Gas Fryer (Japan Only) after 10/2018

Service Manual

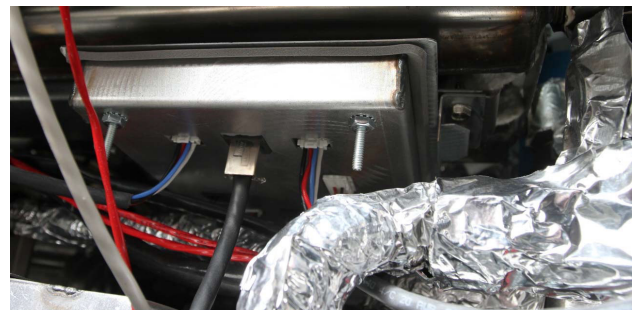
Figure 39

The VIB (Valve Interface Board) controls the actuators that open and close the drain and return valves. The VIB boards are located inside a protective housing under each frypot (see Figure 39).
