Frymaster°

1814E with FilterQuick™

Electric Fryer

Service Manual

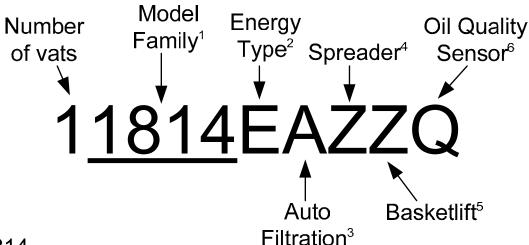
1.1.1 Reading Model Numbers

1 = 1814

2 = E-Electric, N-Natural Gas, P-Propane Gas

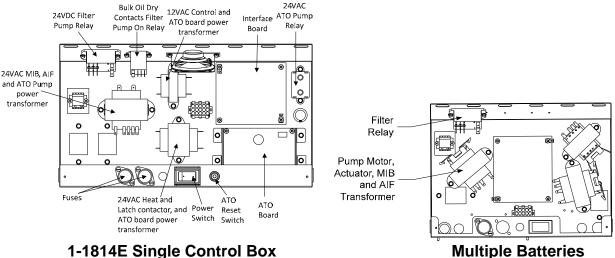
Disconnect the fryer from the electrical power supply. Remove the left controller from the fryer to expose the interior of the left component box. The transformer and relay on the left are located as shown in the illustration below. **NOTE:** The right component box is identical to the left except that the transformer and relay on the left side are not present. Once replaced, reconnect the power.

When replacing a filter relay in the left component box, ensure the 24VDC relay (8074482) is used. Similar Frymaster fryers use a 24VAC relay, which can lead to confusion. The 24VDC is used in the 1814E with FilterQuickTM fryer. If replacing the ATO board see NOTE in section 1.11.3.

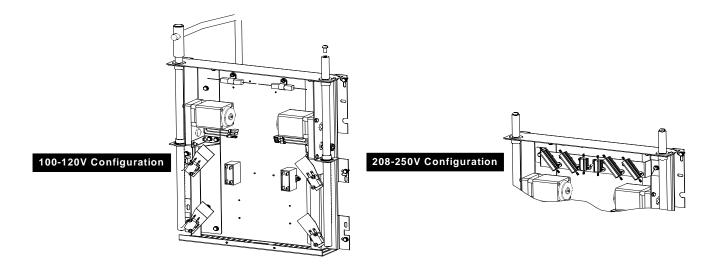
Problems with the basket lift can be grouped into three categories:

- Binding/jamming problems
- Motor and gear problems
- Electronic problems

Noisy, jerky or erratic movement of the lifts is usually due to lack of lubrication of the rods and their bushings. Apply a light coat of Lubriplate[®] or similar lightweight white grease to the rod and bushings to correct the problem.

With the modular basket lift, another possible cause of binding is improper positioning of the motor, which prevents the gear from correctly engaging the teeth in the rod. To correct the problem, loosen the screws that hold the motor in place and move it forward or backward until the rod has just enough slack to be rotated slightly.

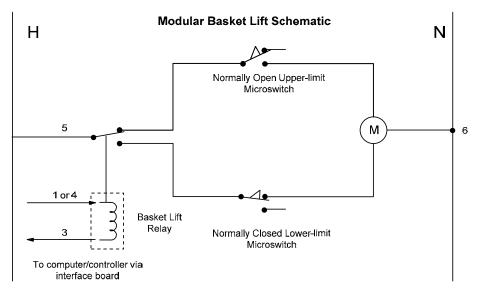
Within this category are problems associated with the relays, microswitches, capacitors, resistors, interface board, wiring, and controls. The most common problem in this category is a lift that continuously travels up and down. This is usually caused by a microswitch that is out of adjustment. Troubleshooting the electronics of a modular basket lift is simply a process of verifying current flow through the individual components up to and including the motor. Using a multimeter set to the 250 VAC range, check the connections on both sides of the component for the presence of the applied line voltage. The schematic below and the wiring diagrams in in the 1814E with FilterQuick wiring diagram manual PN 8197320 can identify the components and wiring connection points.

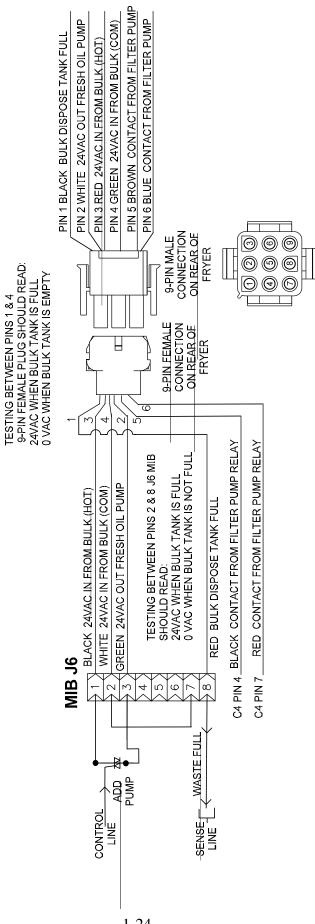
1.13.2 Bulk Wiring

BULK OIL WIRING

The 1814E with FilterQuick™™ fryer will ONLY operate with bulk systems that have the three-pole float switch. If the float switch is the older two-pole switch, call the bulk oil provider. These float switches are polarity specific which may short to ground and damage an MIB board.

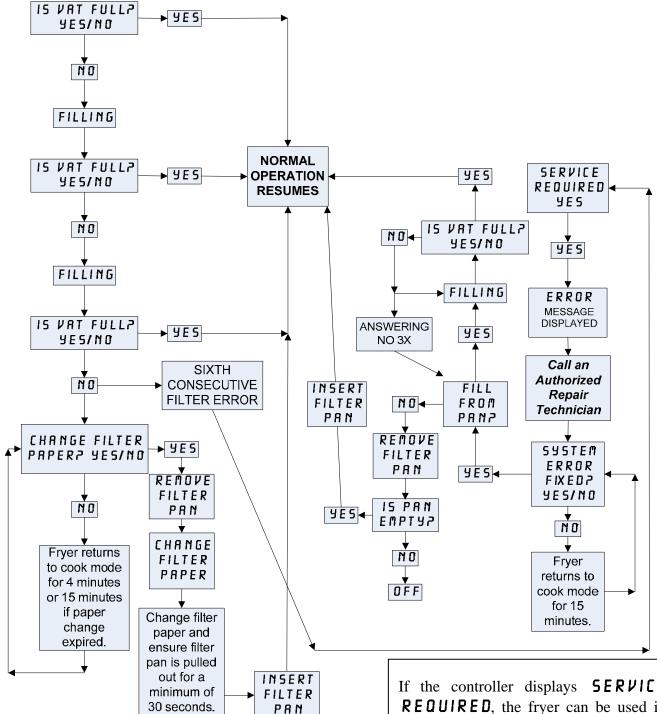
1.15.5 FilterQuick[™] Filter Error Flowchart

This chart follows the process of clearing a filtration issue. The prompt is displayed when any of the following occur:

- 1. a clogged filter pad,
- 2. a tripped or defective filter pump,
- 3. a leaky O-ring on the pick-up tube,
- 4. a failed drain valve/actuator, or
- 5. a failed return valve/actuator.

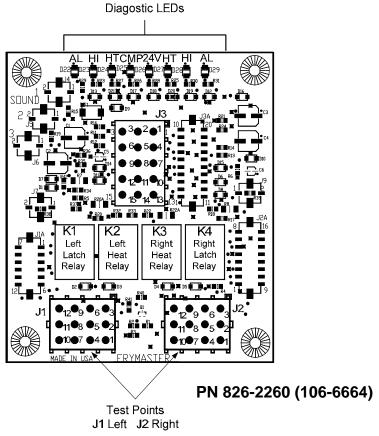
1.18 Interface Board Diagnostic Chart

The following diagram and charts provide ten quick system checks that can be performed using only a multimeter.

Diagnostic LED Legend indicates power from 12V transformer indicates power from 24V transformer НІ (RH) indicates output (closed) from right latch н (LH) indicates output (closed) from left latch relav HT (RH) indicates output from right heat relay (LH) indicates output from left heat relay HT (RH) indicates output (open) from right latch AL AL (LH) indicates output (open) from left latch relay

NOTE - Pin 1 is located in the bottom right corner of Both J1 and J2. These test points are ONLY for FILTERQUICK™ Series boards with J1 and J2 plugs on the front of the board.
