FQE80U FilterQuick[™] easyTouch[®] Electric Fryer

Service Manual

Part Number: FRY_SM_8197953 02/2025

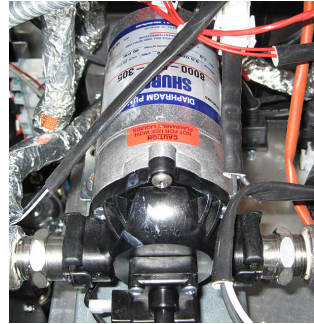
Figure 22

Disconnect the fryer from the electrical power supply. Locate the ATO pump (see Figure 22. Mark and unplug any wires or harnesses. Press down from the top on the quick disconnects to release the plumbing (see Figure 23). The plumbing can be pulled from the pump. Loosen the four nuts attaching the pump to the pump tray. Disconnect the electrical connection. Replace the defective component and reverse above steps. Once replaced, reconnect the power.

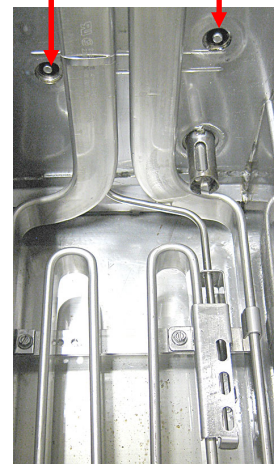
Figure 24

VIB (AIF) Probe ATO Probe

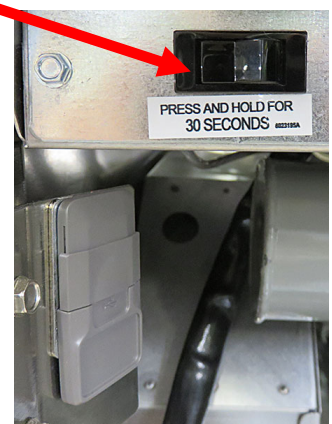
Figure 34

25. Cycle the fryer control power using the switch on the front of the left contactor box (see Figure 34). **ENSURE THE SWITCH IS TURNED OFF FOR 60 SECONDS.**
