# FilterQuick™ FQG80T/100T/120T easyTouch® Gas Fryer

## Service Manual

Part Number: FRY\_SM\_8197955 04/2025

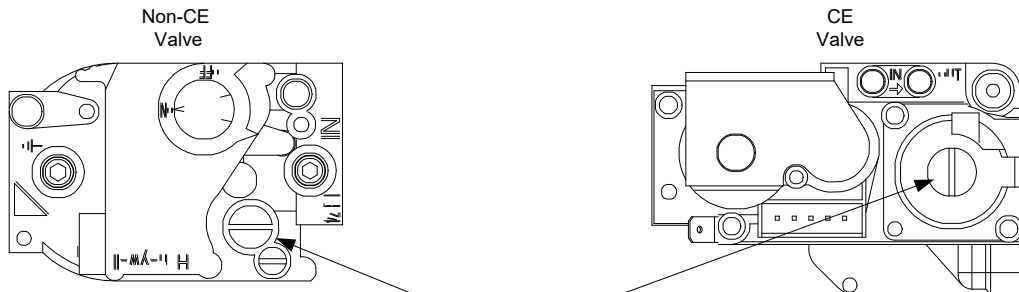
Figure 1B

GAS VALVE REGULATOR CAP

2. Remove the pressure tap plug from the gas valve assembly (see Figure 1B).
3. Insert the fitting for a gas pressure-measuring device into the pressure tap hole.
4. **On non-CE fryers only**, place the gas valve in the ON position
5. Place the fryer power switch in the ON position. When the burner has lit and burned steadily for at least one minute, compare the gas pressure reading to the pressure for the corresponding gas in the appropriate table on the following page. The tables on the following page list the burner manifold gas pressures for each of the gas types that can be used with this equipment.
6. To adjust the burner gas pressure, remove the cap from the gas valve regulator and adjust to the correct pressure.

7. Place the fryer power switch (and the gas valve in non-CE fryers) in the OFF position. Remove the fitting from the pressure tap hole and reinstall the pressure tap plug.

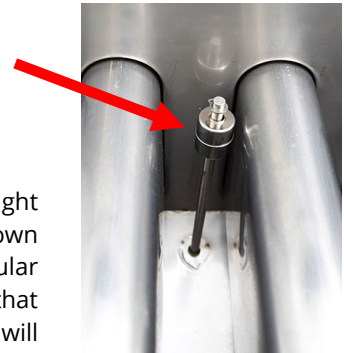
Figure 33

The main indicators of this are that the fryer may light intermittently, fail to light or light with low oil levels. A visual clue is the float switch (see Figure 33) is stuck in the down position with oil over it or stuck in the up position with the oil level below it. Regular cleaning of the float switch prevents this issue. Ensure when removing the float switch that its position is clearly marked and replaced properly. Installing the float upside down will change the switch from N/O to N/C. This could allow the empty frypot to ignite. See float switch troubleshooting in Section 1.22.5.1.

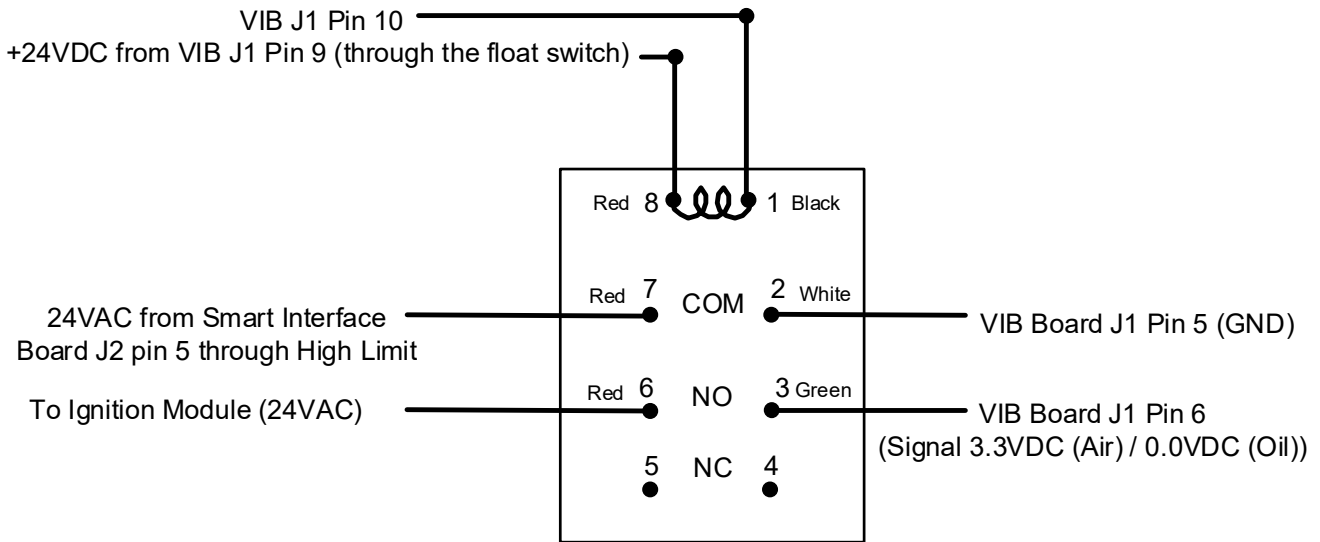
**Figure 55**

### 1.22.5.2 Float Switch Sensor Time Delay Relay Wiring Diagram

**Time Delay Relay Board  
DPDT 3.5 sec.**
