Service Bulletin

Subject: UHCTHD Communication/Configuration Errors

Models: McDonald's UHCTHD Touch Screen Holding Cabinets

4/29/2024

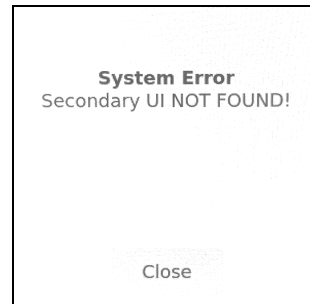
Figure 2

If a UHCTHD Touch cabinet displays "Waiting for Primary UI" (see Figure 1) or "System Error Primary UI communication loss." (see Figure 2) on the **REAR** controller and "System Error Secondary UI NOT FOUND!" (see Figure 3) or "System Error Secondary UI communication loss" (see Figure 4) on the **FRONT** controller, a communication issue has occurred.

Errors shown in Figures 1 and 3 occur when **NO** communication occurs between the front and rear controllers during power up. Errors shown in Figures 2 and 4 occur when communication occurred at power up, but then **was later lost** between the controllers. Pressing the Close button on the front controller, allows it to function normally. The rear controller does not allow the display to clear until the issue is addressed.

If a loss of communication has occurred between the front and rear controllers. See **RESOLUTION A** on the following page to address the issue.

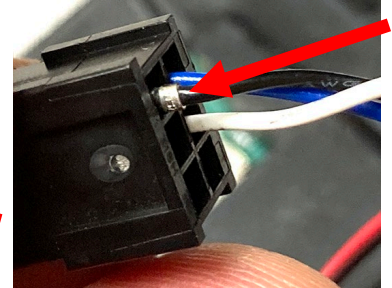
Figure 6

- Remove the four (4) Phillips screws on the top of the cabinet and remove the cabinet top.
- Disconnect the CAN communication cables (3-wire, 6-pin connectors) on both ends between the front and rear touch screen controllers, with the black, blue and white wires (see Figure 6).

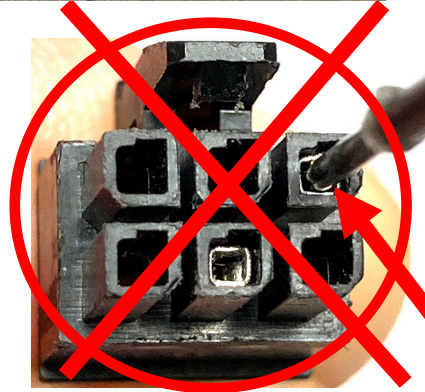
Figure 6.2

- Ensure the connector, that attaches directly to the rear of the touch screen, is fully inserted into the connector by pressing in on both sides of the connector (see Figure 6.2). The photo shown above shows the right side slightly out of the connector. It may require disconnecting and reconnecting the connector. Both sides of the connector should be flush against the connector on the board.**

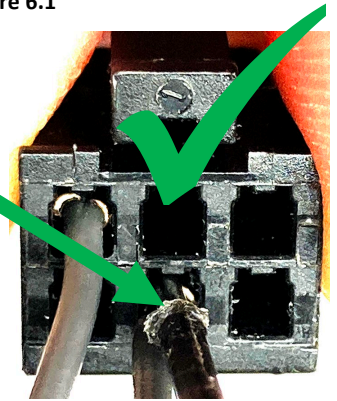
Figure 7

- DO NOT** test harness with needle pin test leads into the front of the pins. The leads will destroy the pins (see Figure 7). If the pins must be tested, the correct way to test the pins is to insert the lead into the connector from the **REAR** side (see Figure 8).

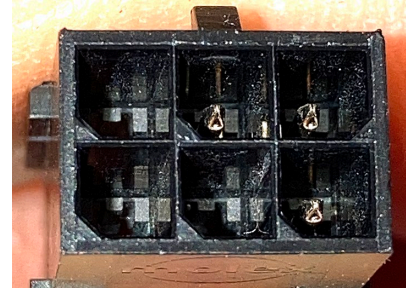
Figure 10

7. Using electrical contact cleaner, clean **BOTH** CAN connectors on the rear of the controllers, with the male pins (see Figure 10).
8. Disconnect and reconnect the CAN cable to both controllers six (6) times.
9. Inspect the CAN cable connectors to ensure **ALL** pins are fully seated into the connectors. Inspect the CAN cable connectors for spread pins (see Figure 11). **NOTE:** The middle pin is spread open compared to the other pins. This may cause intermittent or constant communication issues.

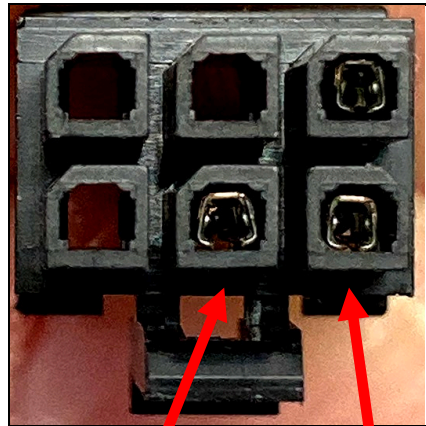
Figure 11

10. If any pins are spread as shown in Figure 11, take a small screwdriver or sharp object that will slide down between the notched side of the connector and the side of the pin. Gently push the sides of the pin back together so the pins make a positive contact (see Figure 12).
