## Service Bulletin

**Subject: Intuition Combustion Fan Wiring & Orientation**

**Models: Frymaster Intuition Gas Fryers**

**9/28/2026**

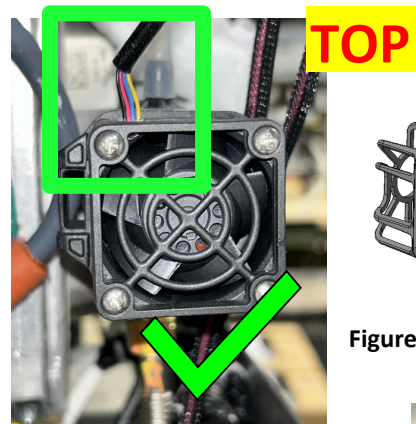
Figure 1

The combustion fan wires **SHOULD** be routed out the top of the combustion fan assembly (see Figures 1 and 2).

Remove the 4 (four) screws attaching the fan to the assembly and reorient the fan as shown in Figures 1 and 2, with the wires exiting the top of the fan.

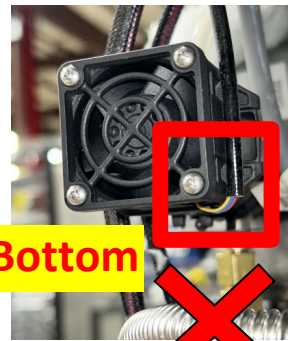
Figure 3

Improper routing of the combustion fan wires may cause pinching or cut wires. This can lead to errors such as E125 Pressure Switch Not Closed, E126 Fan Calibration Error or E124 Fan Failure.

The wires **SHOULD NOT** be routed out the bottom or side of the assembly (see Figures 3 and 4), as this may allow the filter housing tabs to pinch and/or cut the wires (see Figures 5 and 6).

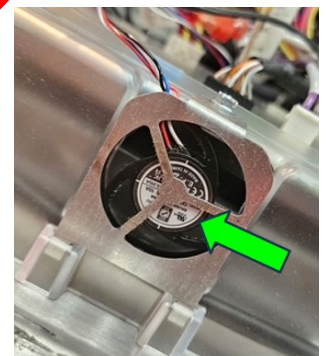
After reorienting the combustion fan, check the orientation of the HCB cooling fan on the top of the HCB cooling housing. The label of the fan should be visible, and the fan should be blowing air out of the top of the cooling housing (see Figure 7).
